**Project:** Knights Stream Park Stages  
7 and 8

Geotechnical Subdivision Report

**Reference:** 200376

**18 November 2014**

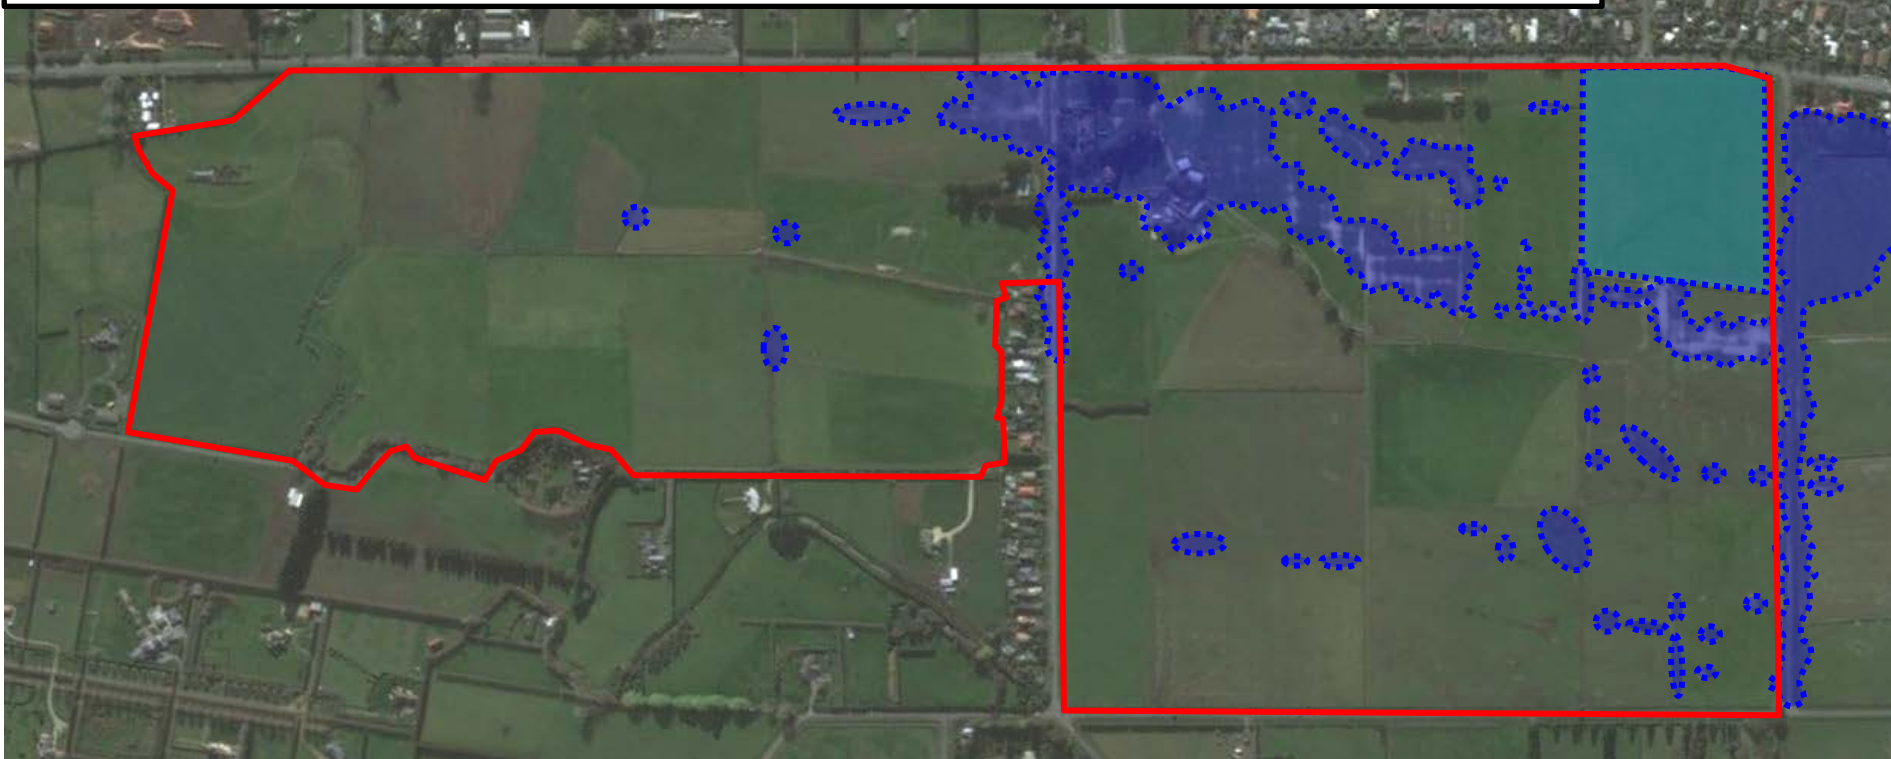
Extensive of liquefaction in the northeastern paddock. Due to long grass at the time of the aerial photographs and site walkovers the exact extent of liquefaction is difficult to fully map

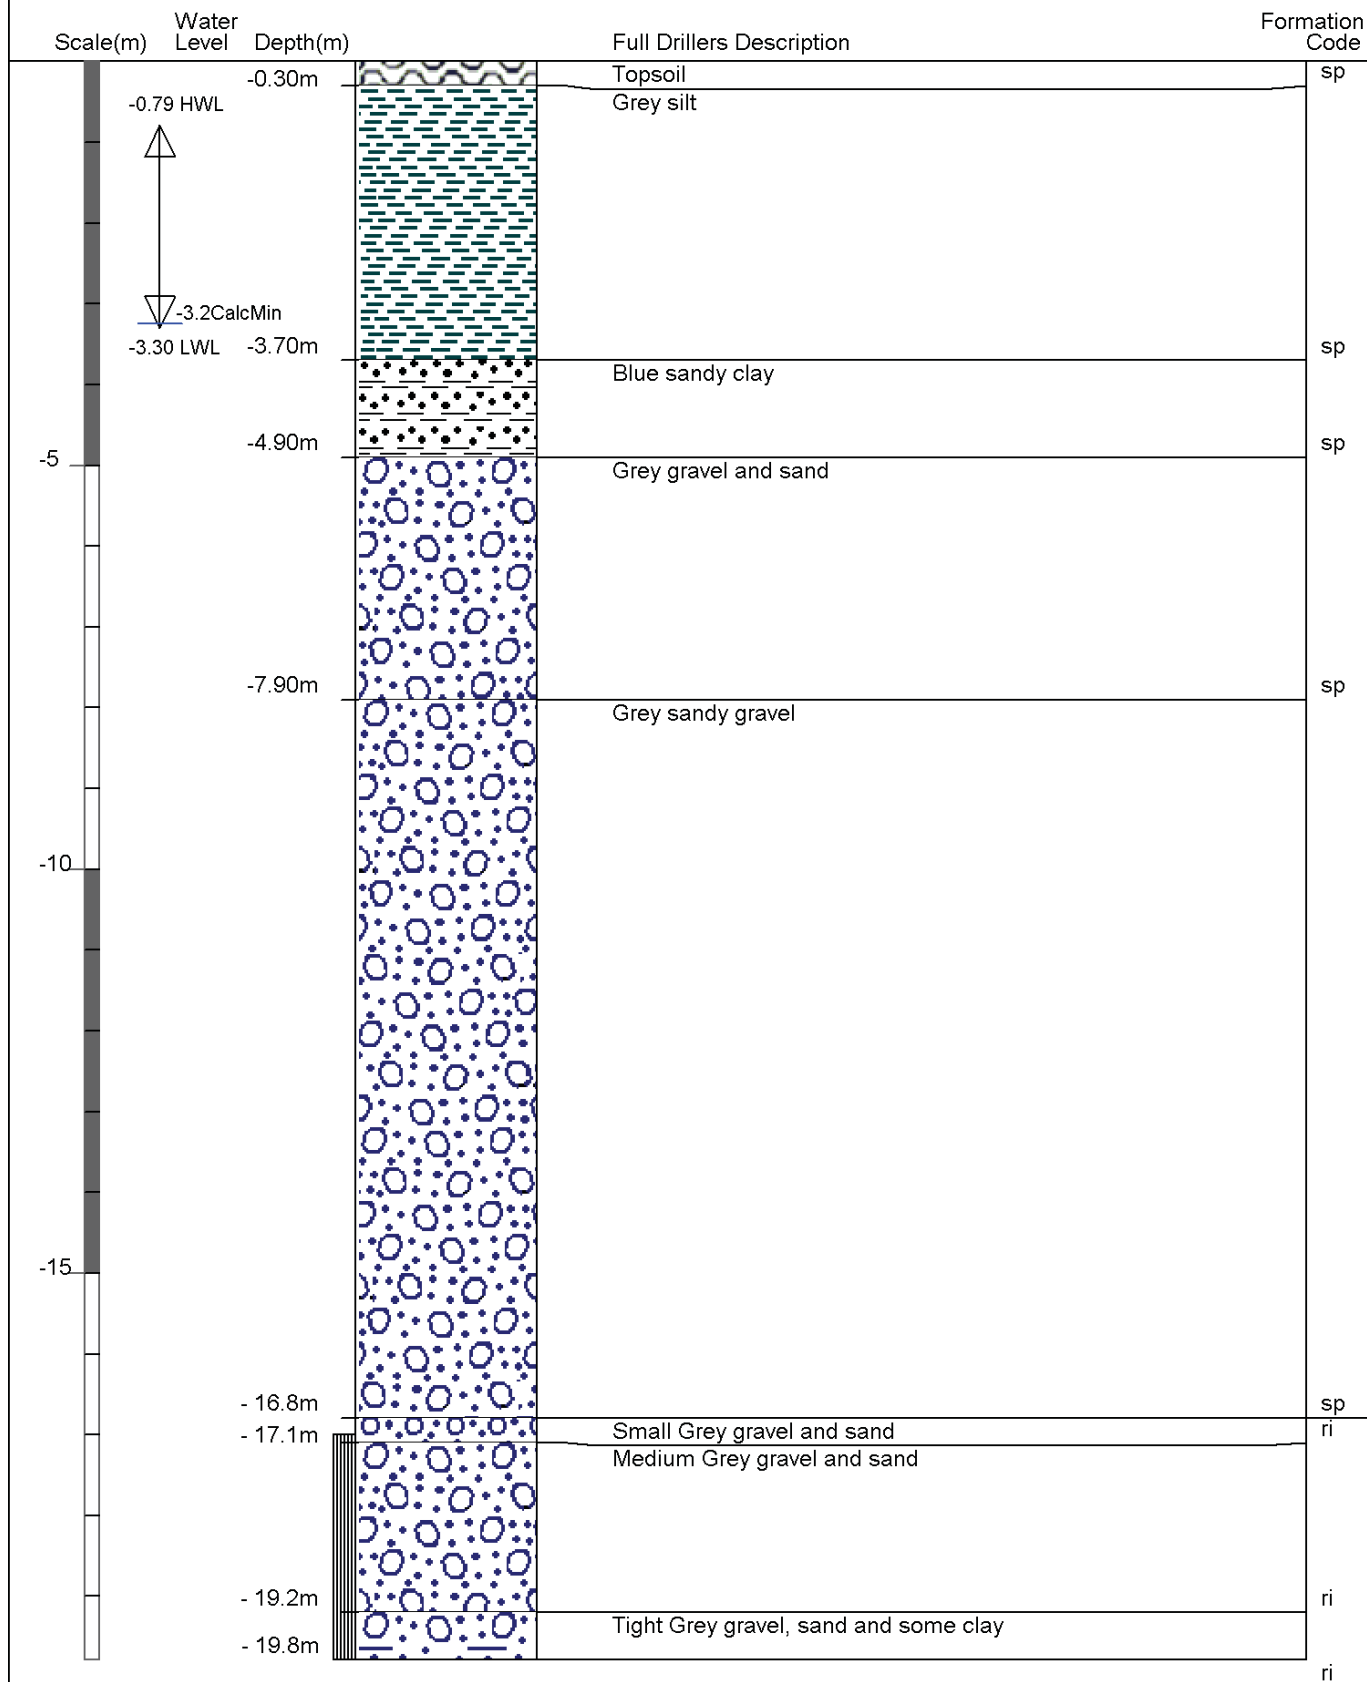
# Borelog for well M36/20150

Gridref: M36:72736-37744 Accuracy : 2 (1=high, 5=low)  
 Ground Level Altitude : 19 +MSD  
 Driller : McMillan Water Wells Ltd  
 Drill Method : Rotary/Percussion  
 Drill Depth : -13.2m Drill Date : 20/10/2008

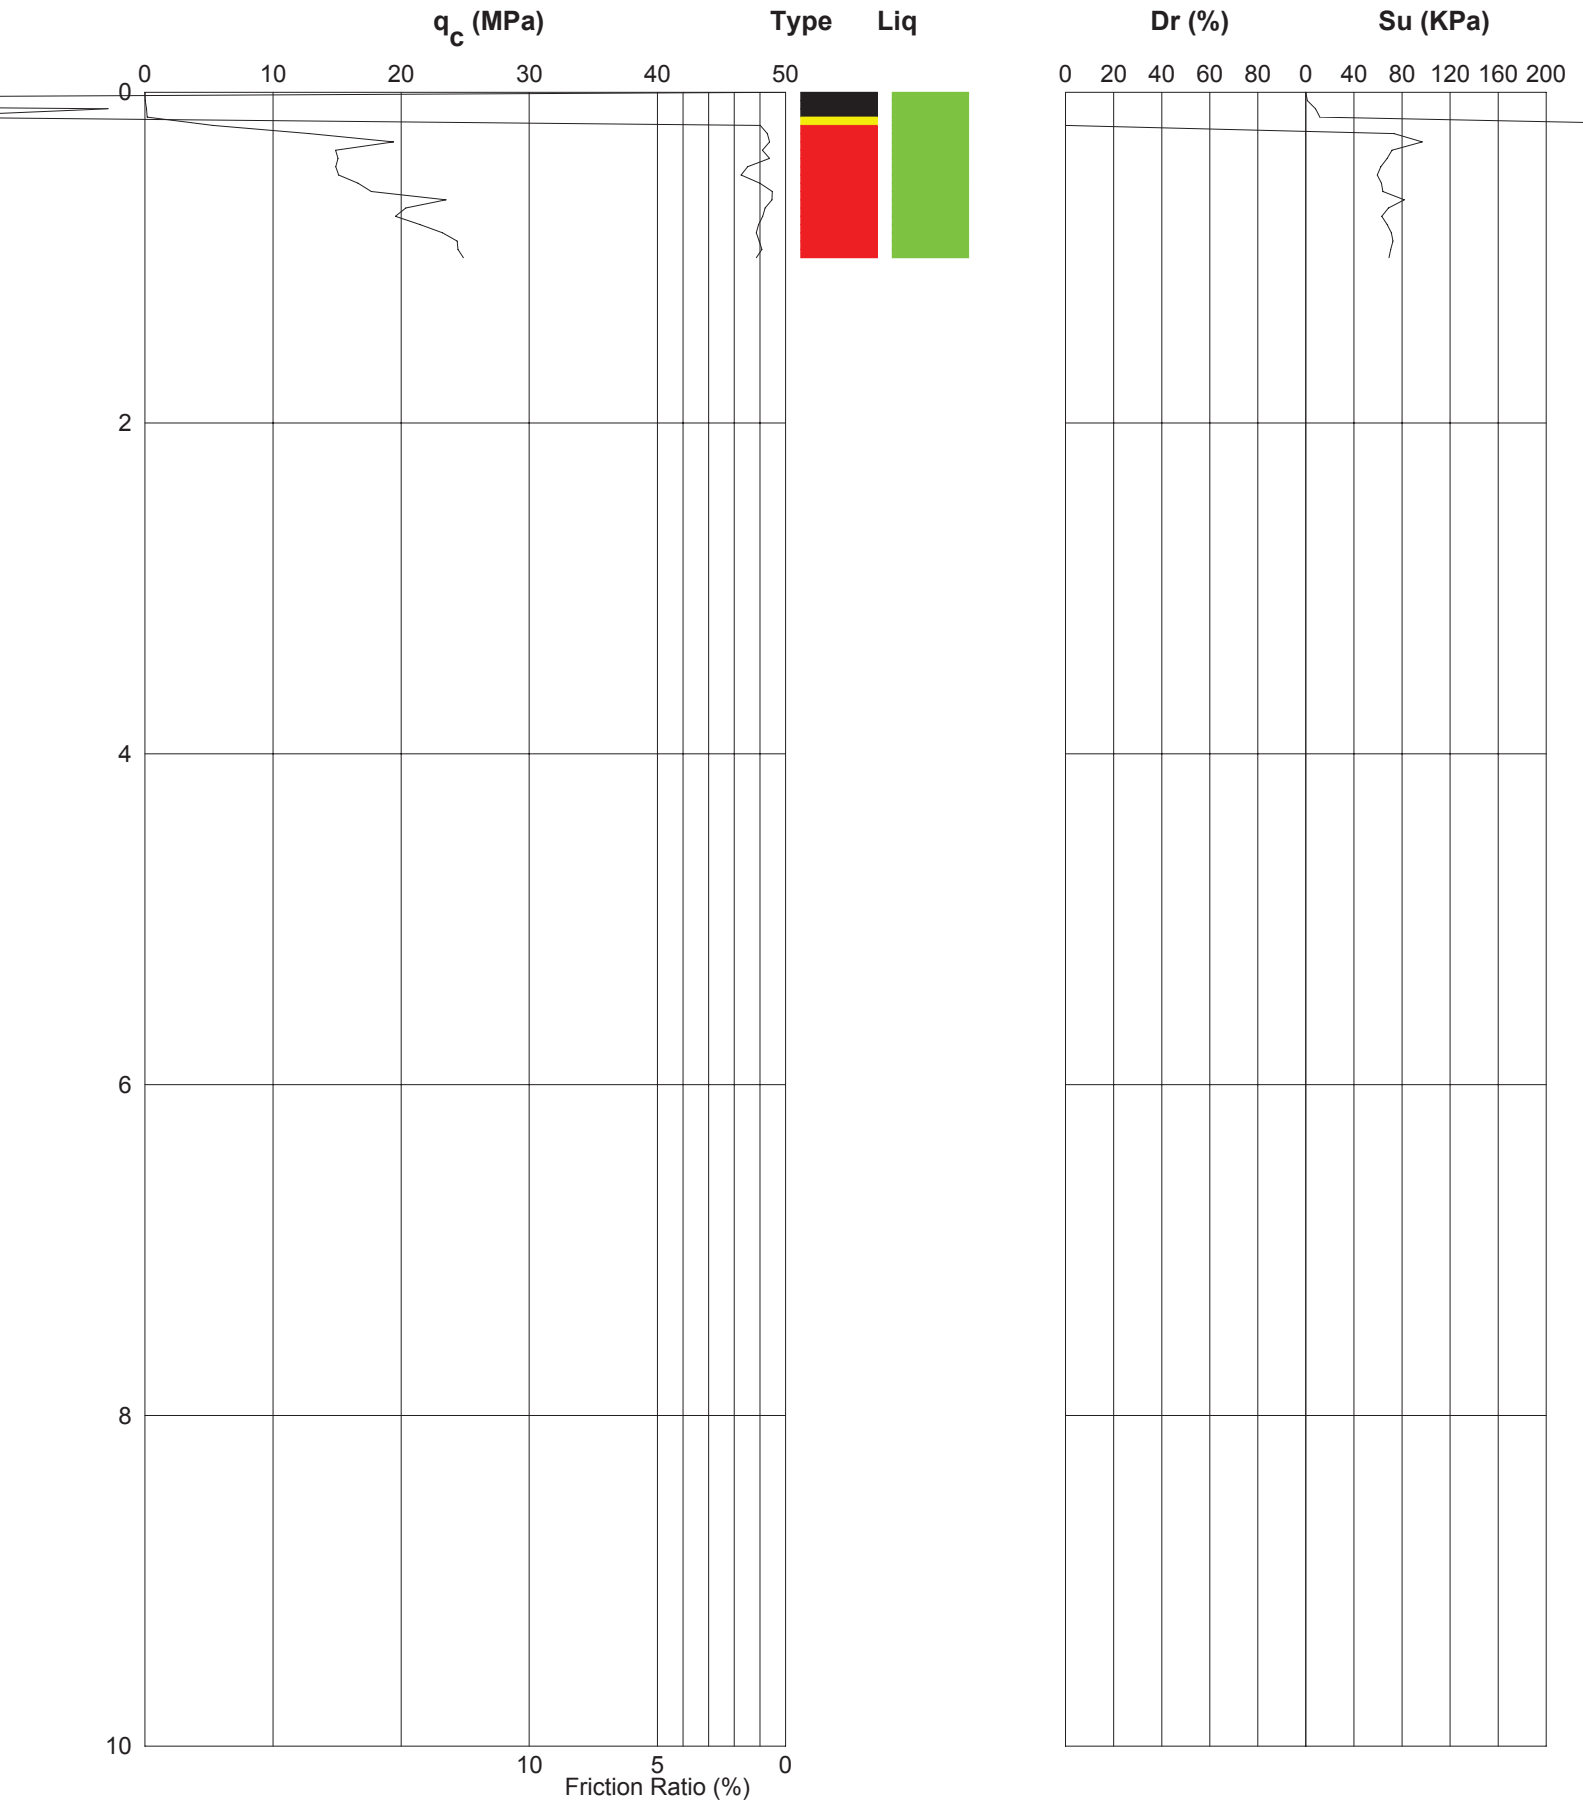
# PIEZOCONE PENETROMETER TEST (CPTU) INTERPRETIVE REPORT

Job No: 8200  
 CPT No: CPT022  
 Project: Fulton Hogan Ltd  
 Location: Halswell Junction Rd

Date: 27-10-2010  
 Operator: N Barnes  
 Remark: Effective Refusal

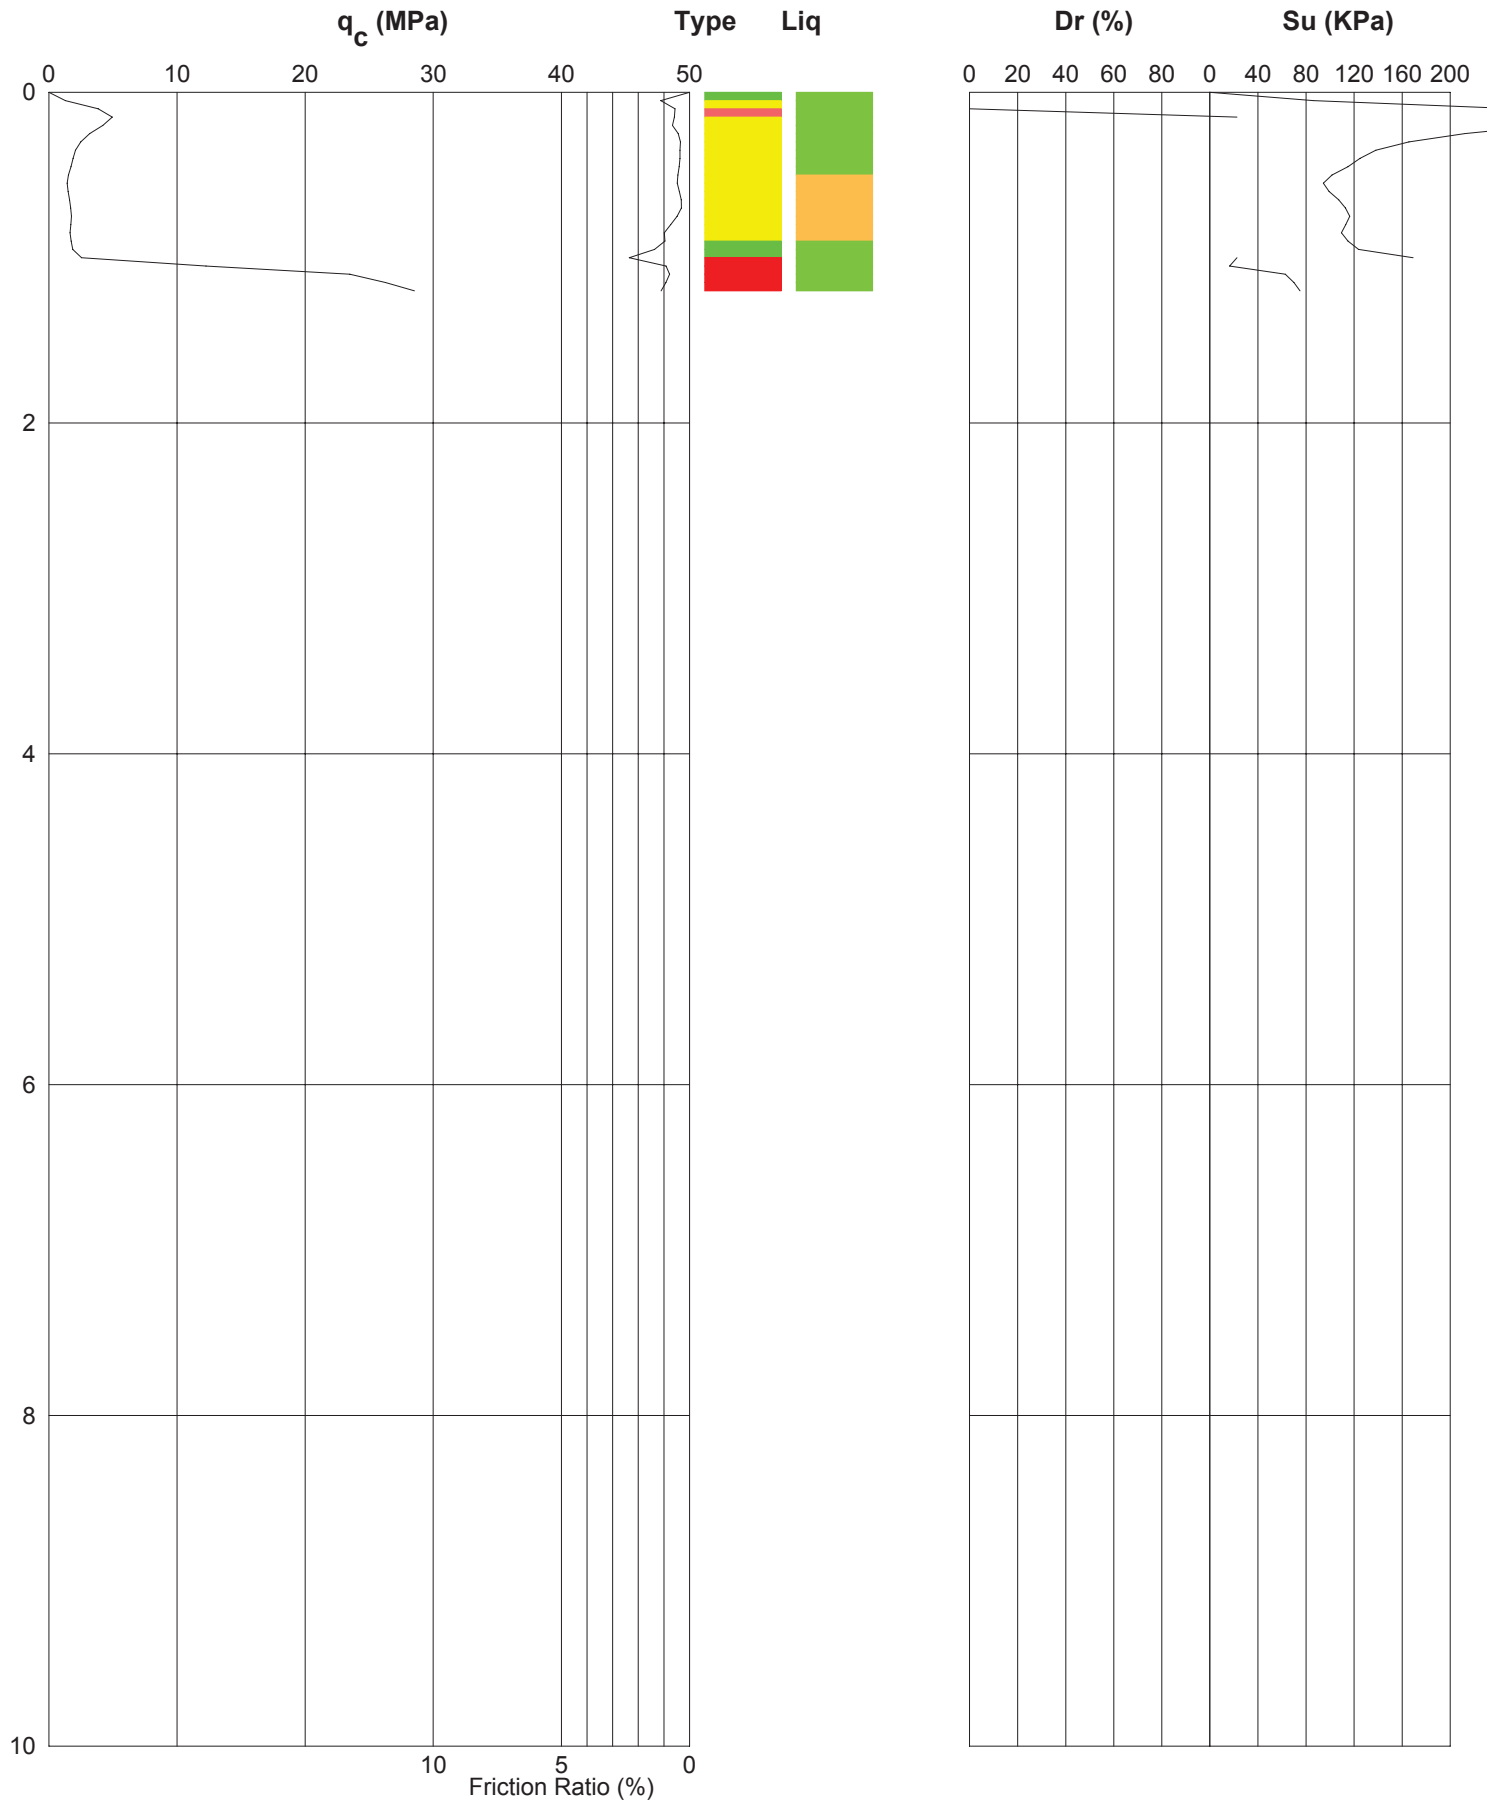
Job No: 8200  
 CPT No: CPT025  
 Project: Fulton Hogan Ltd  
 Location: Halswell Junction Rd

# PIEZOCONE PENETROMETER TEST (CPTU) INTERPRETIVE REPORT

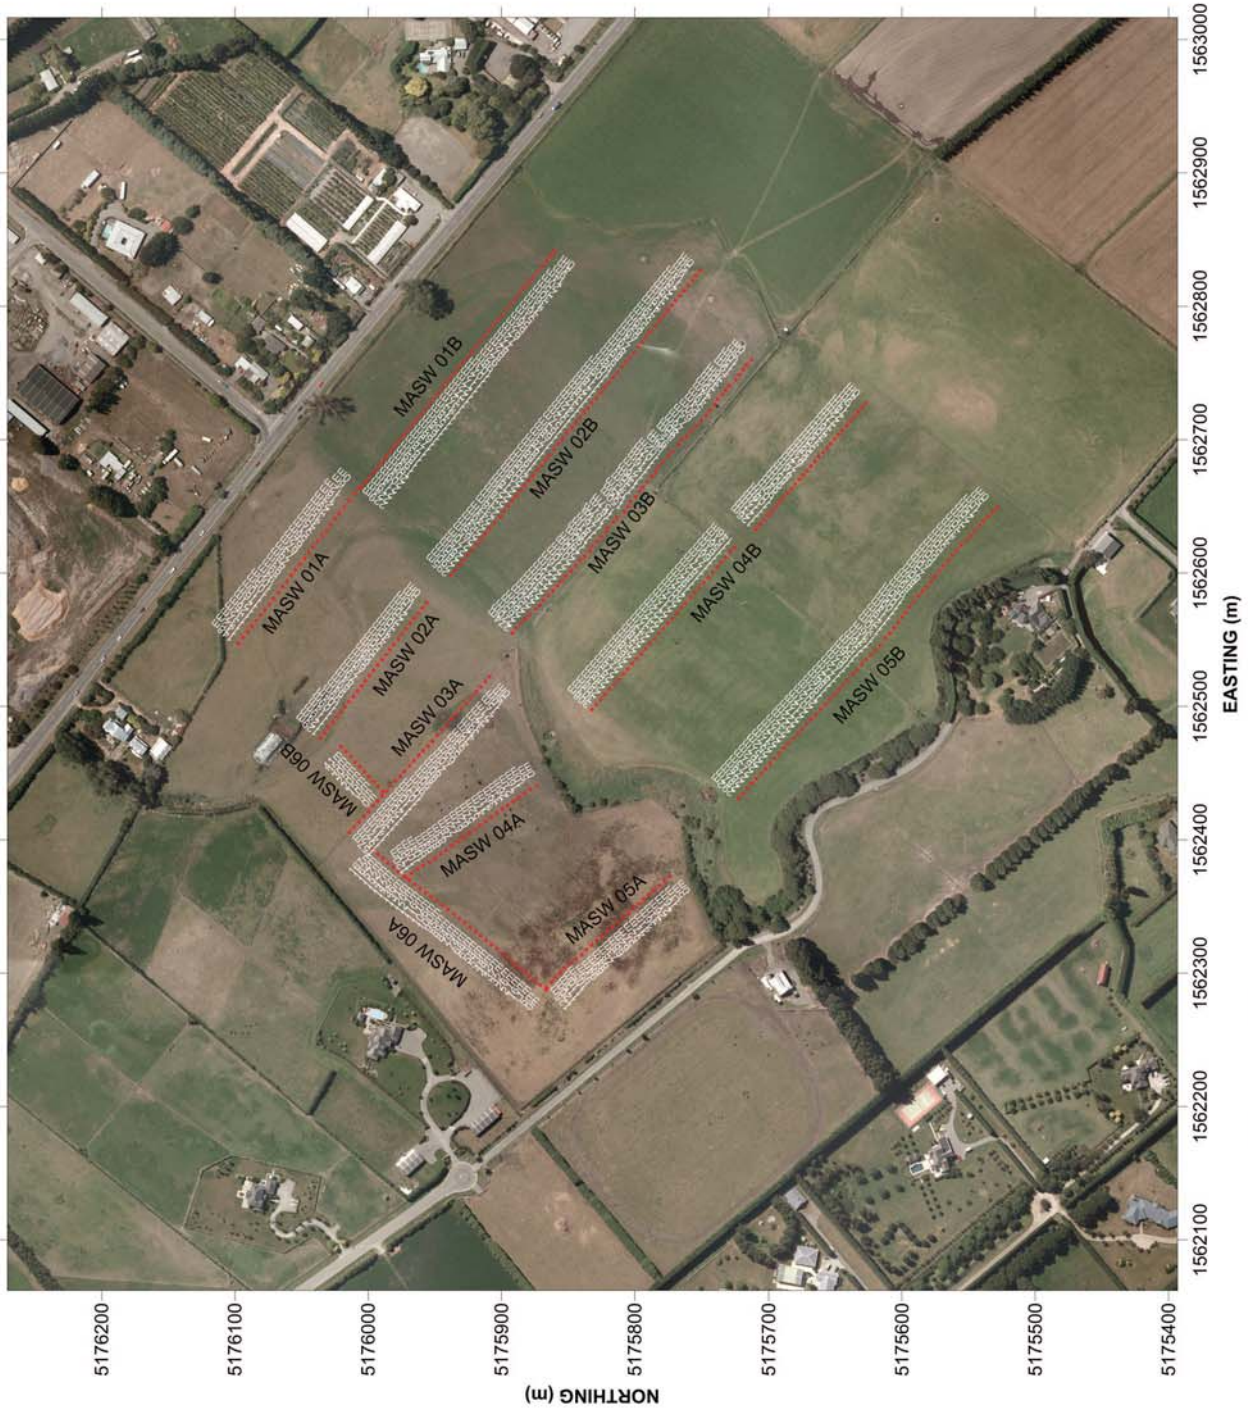
TITLE-	KNIGHT STREAM STAGE 6 & 7	
	MASW LINE LOCATIONS	
LOCATION-	HALSWELL, CHRISTCHURCH	
NOTES-	Coordinates NZ2000 TM Grid.	
	Aerial photograph post February 2011.	
	Line labels show the chainage along the line.	
	Each point represents the midpoint of the 24m MASW array.	
		A3
		<div> <a href="http://www.southerngeophysical.com">www.southerngeophysical.com</a></div>

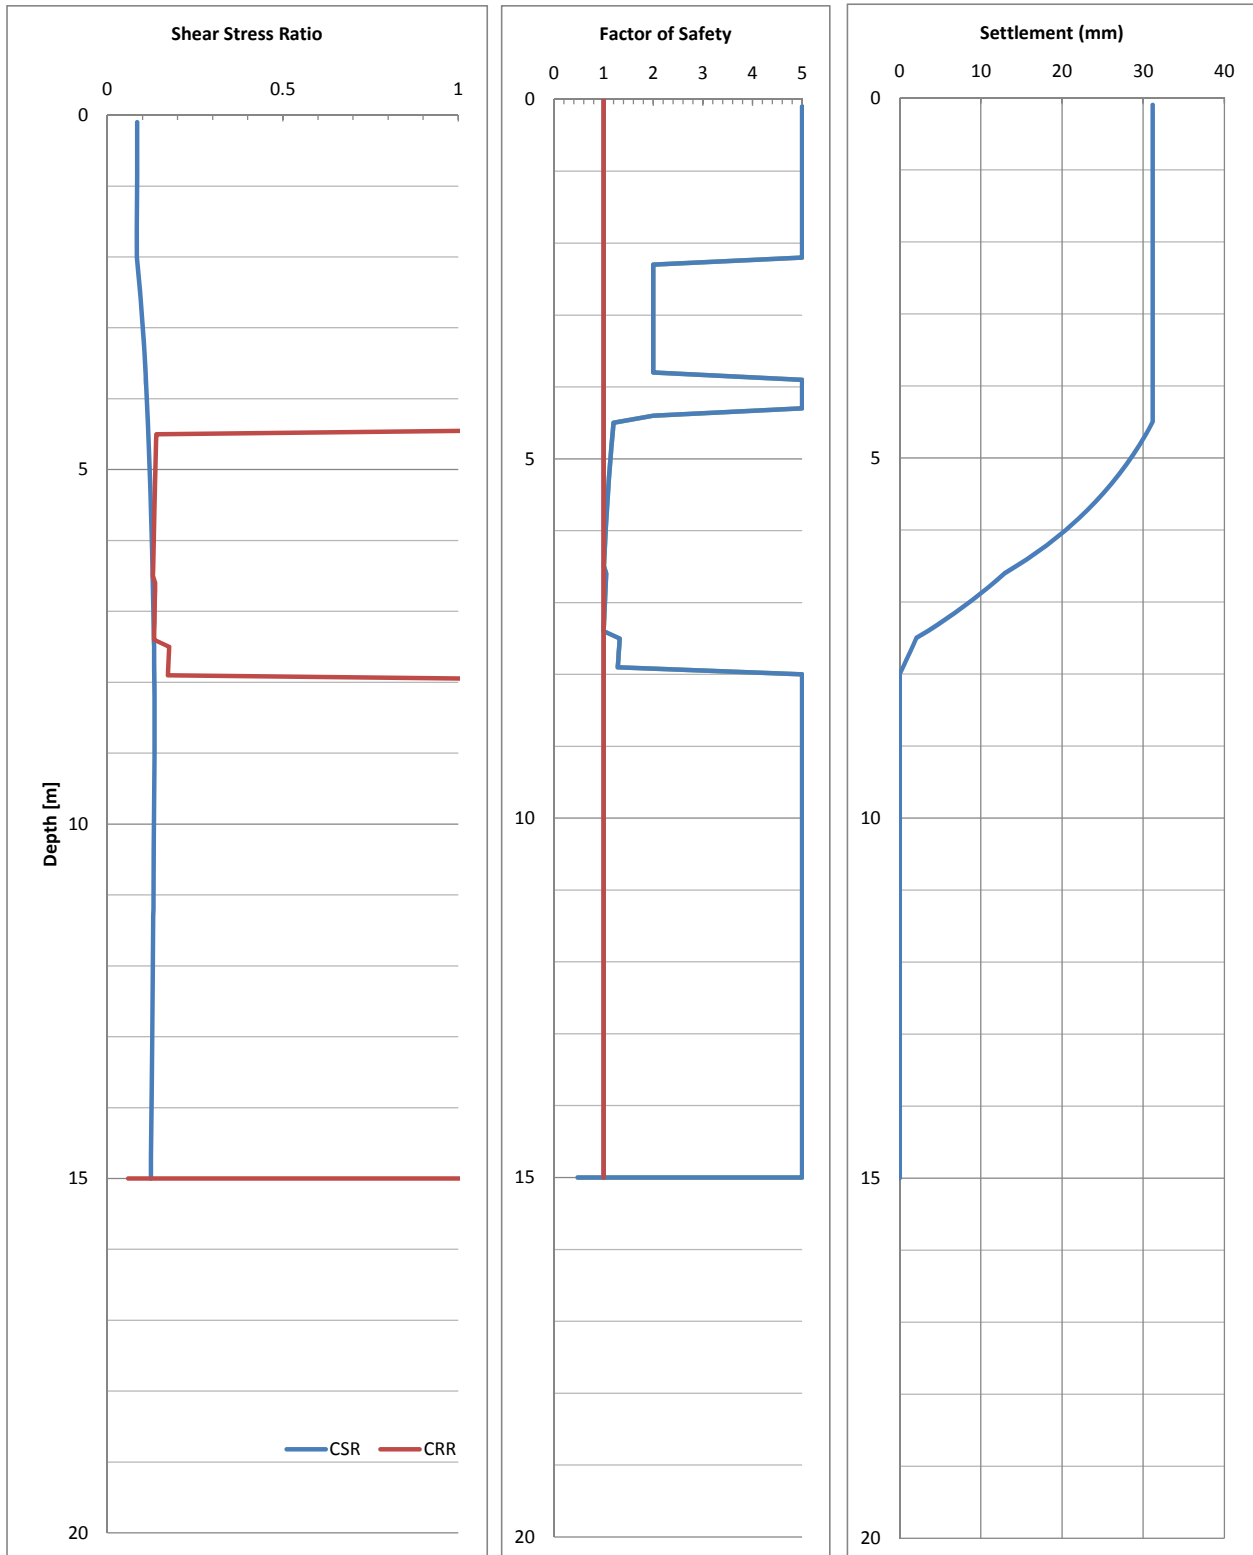
# LIQUEFACTION ANALYSIS

Based upon method outlined in Idris and Boulanger (2008)

Settlement (mm): 31  
LSN: 5

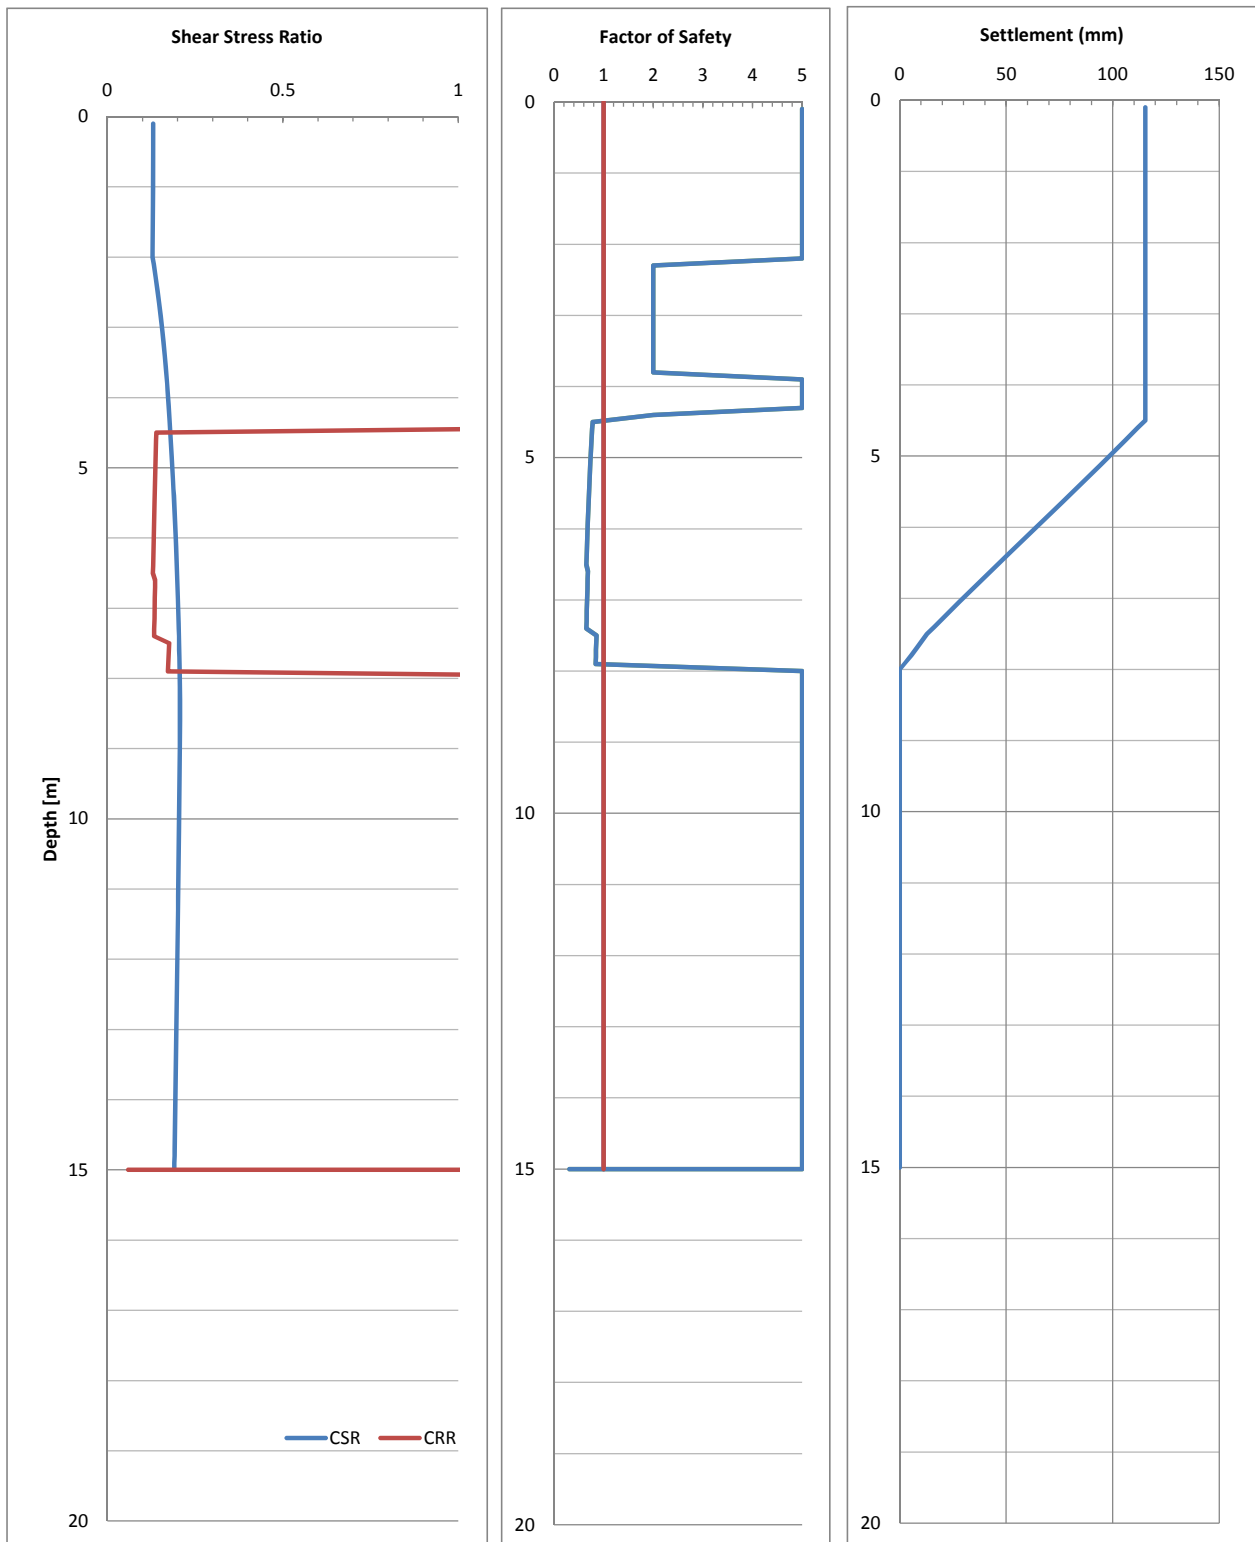
# LIQUEFACTION ANALYSIS

Based upon method outlined in Idris and Boulanger (2008)

Settlement (mm): 115

LSN: 19

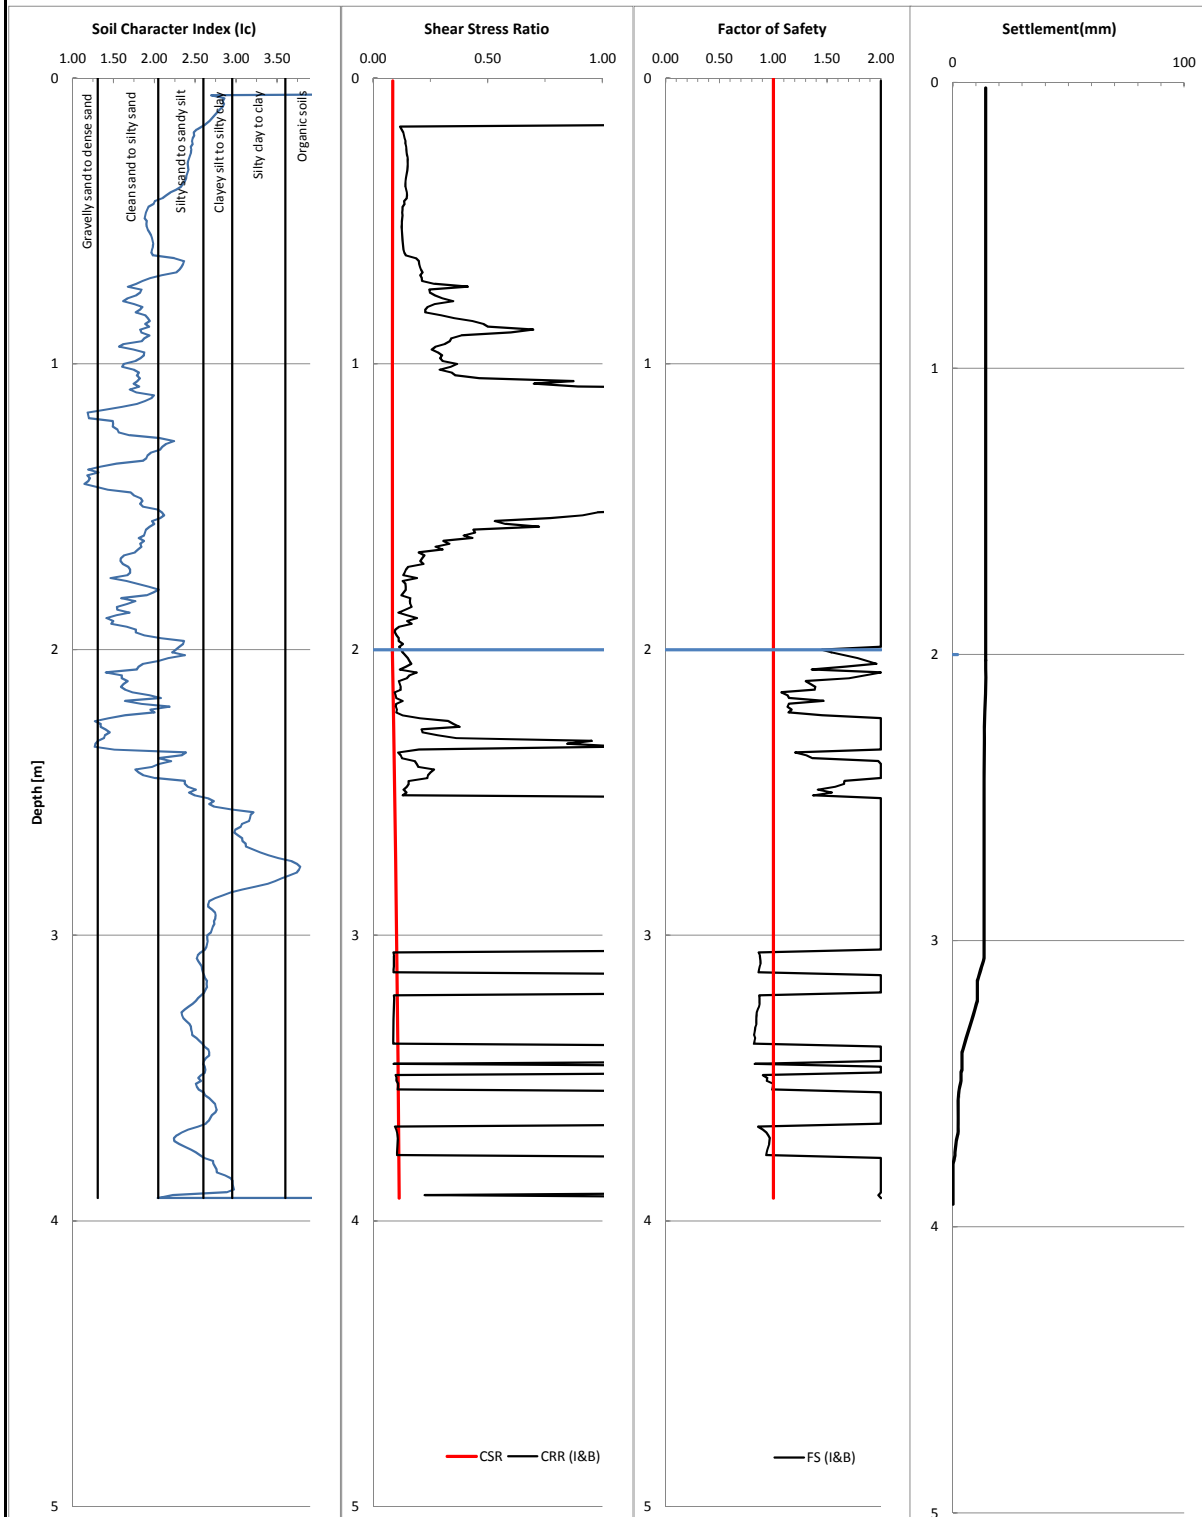
**LIQUEFACTION ANALYSIS**

Water Table [m] 2.00  
 Magnitude 7.50  
 Acceleration [g] 0.13

**Total Settlement (mm): 14**  
**LSN: 4**

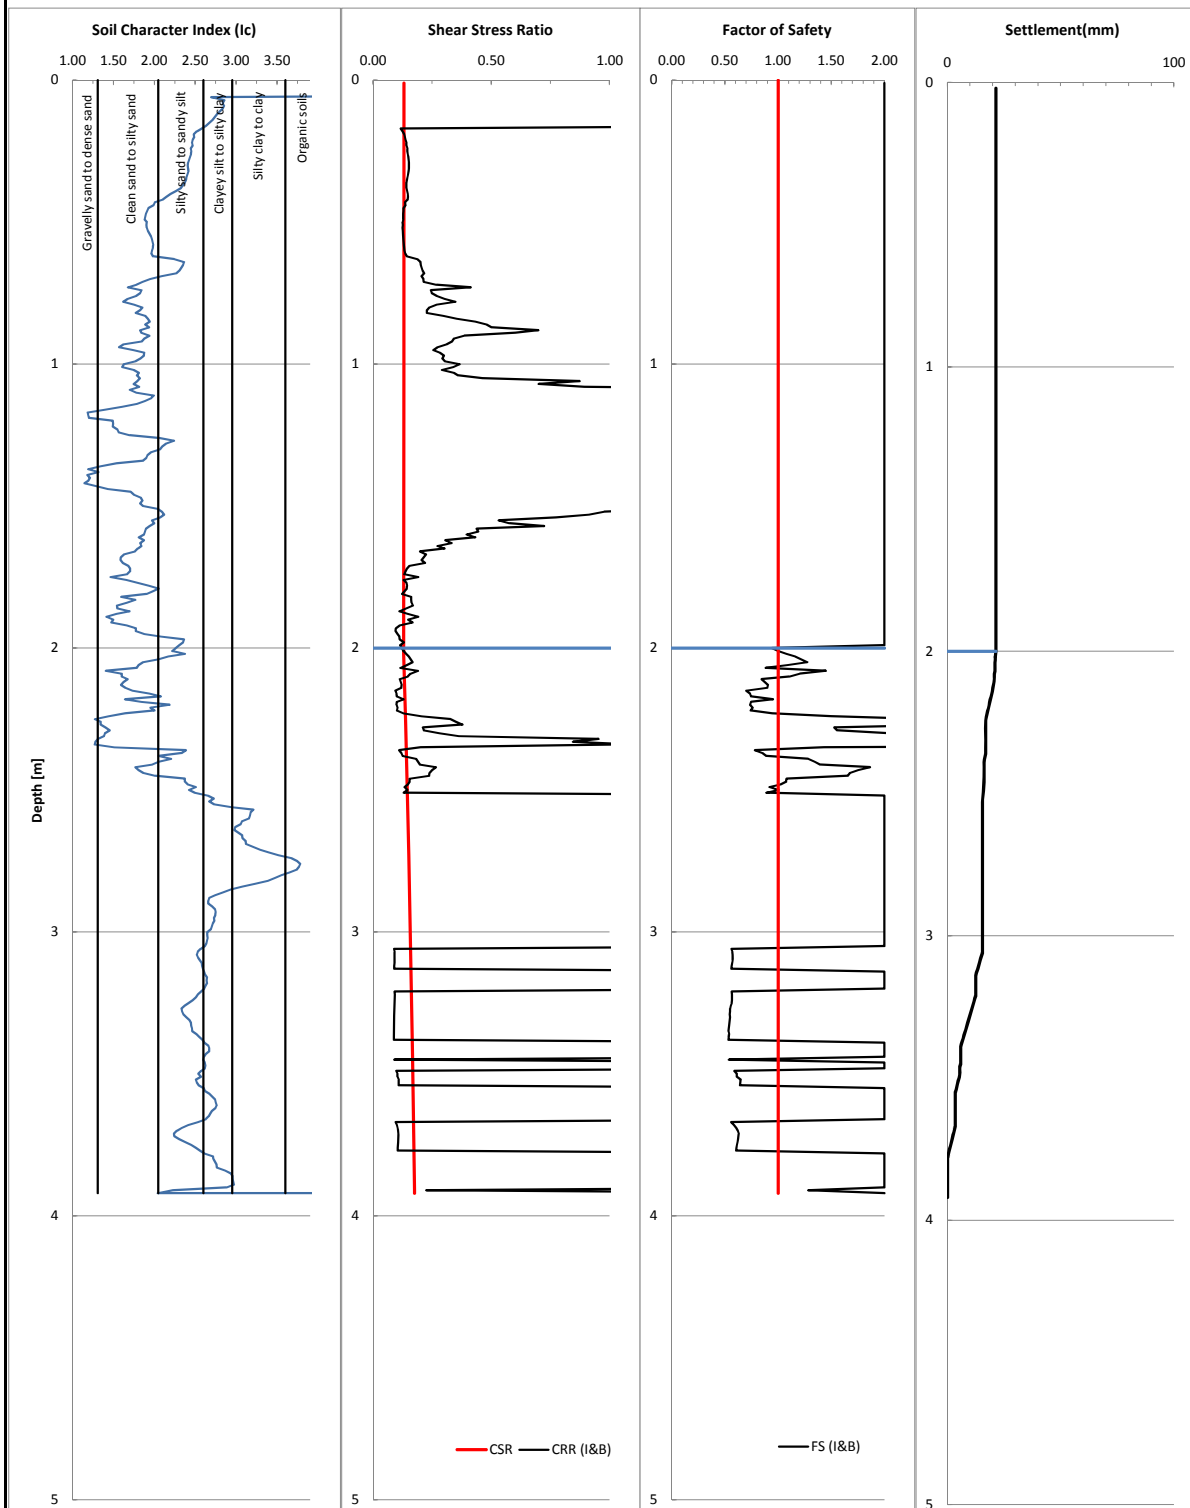
**LIQUEFACTION ANALYSIS**

Water Table [m] 2.00  
 Magnitude 7.50  
 Acceleration [g] 0.20

Total Settlement (mm): 21  
 LSN: 7

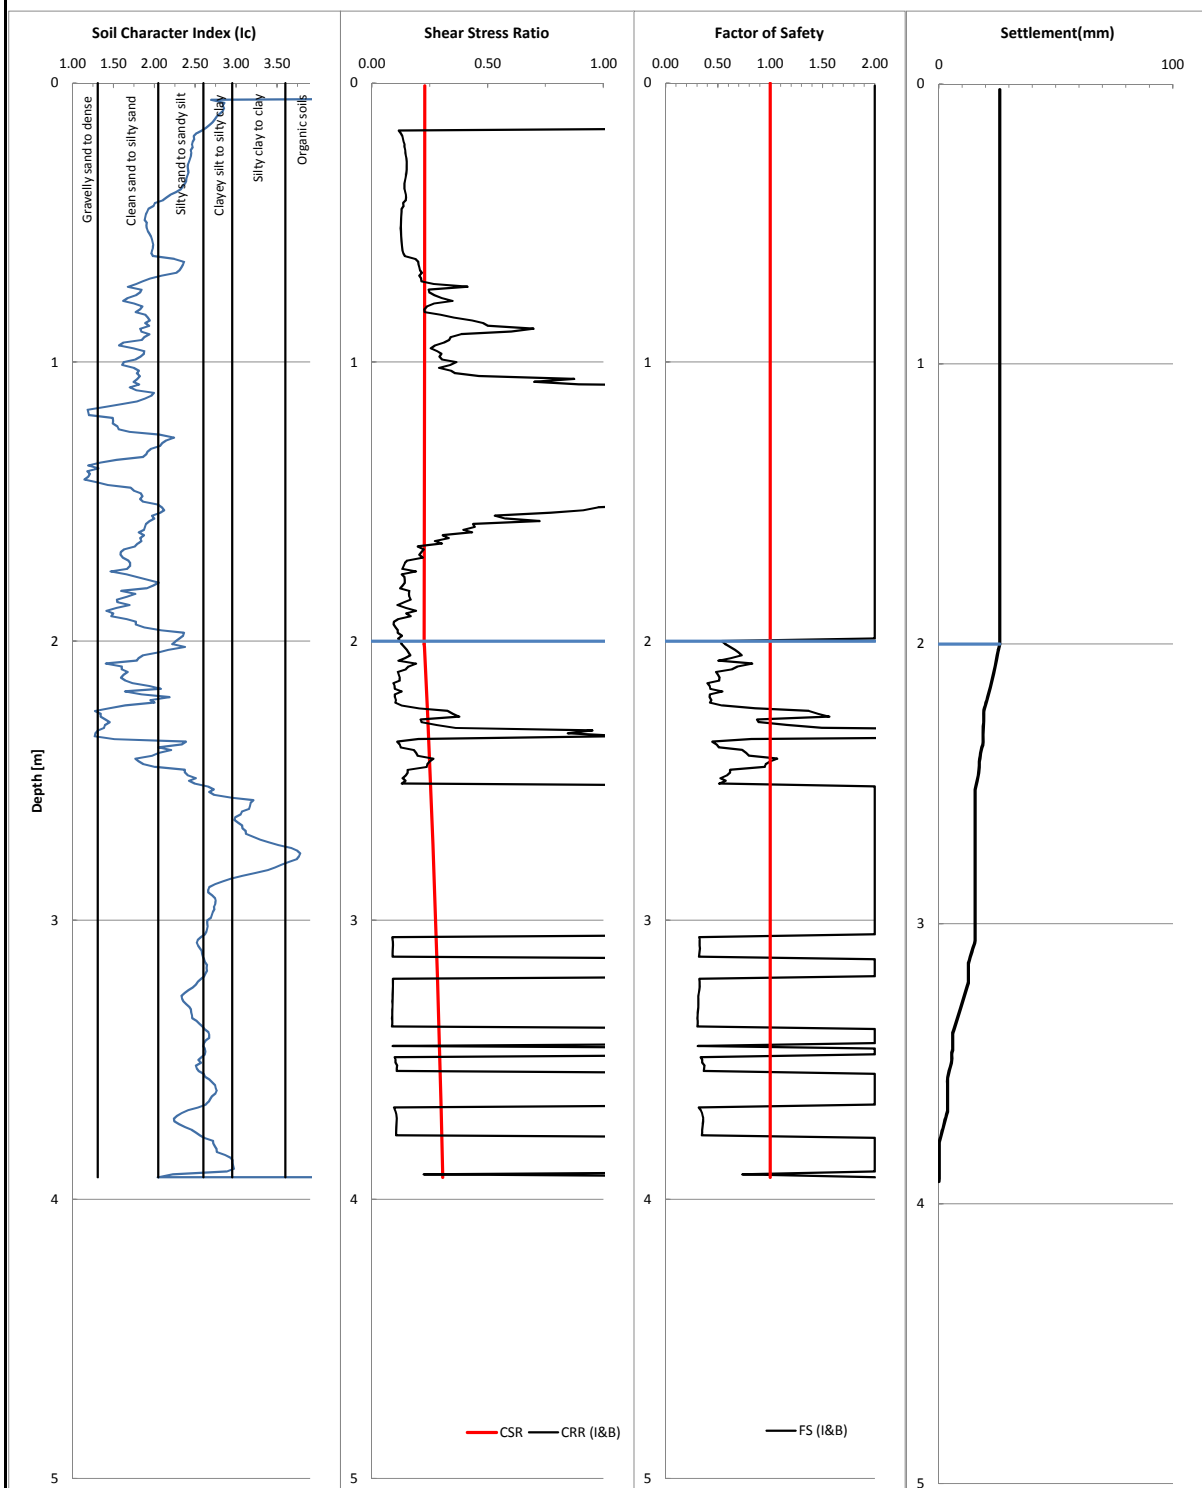
**LIQUEFACTION ANALYSIS**

Water Table [m] 2.00  
 Magnitude 7.50  
 Acceleration [g] 0.35

Total Settlement (mm): 26  
 LSN: 9
