**Rosemerryn Subdivision, Lincoln**

Stages 10 to 18 Geotechnical  
Investigation Report

**Fulton Hogan Land Development  
Limited**

25 September 2015

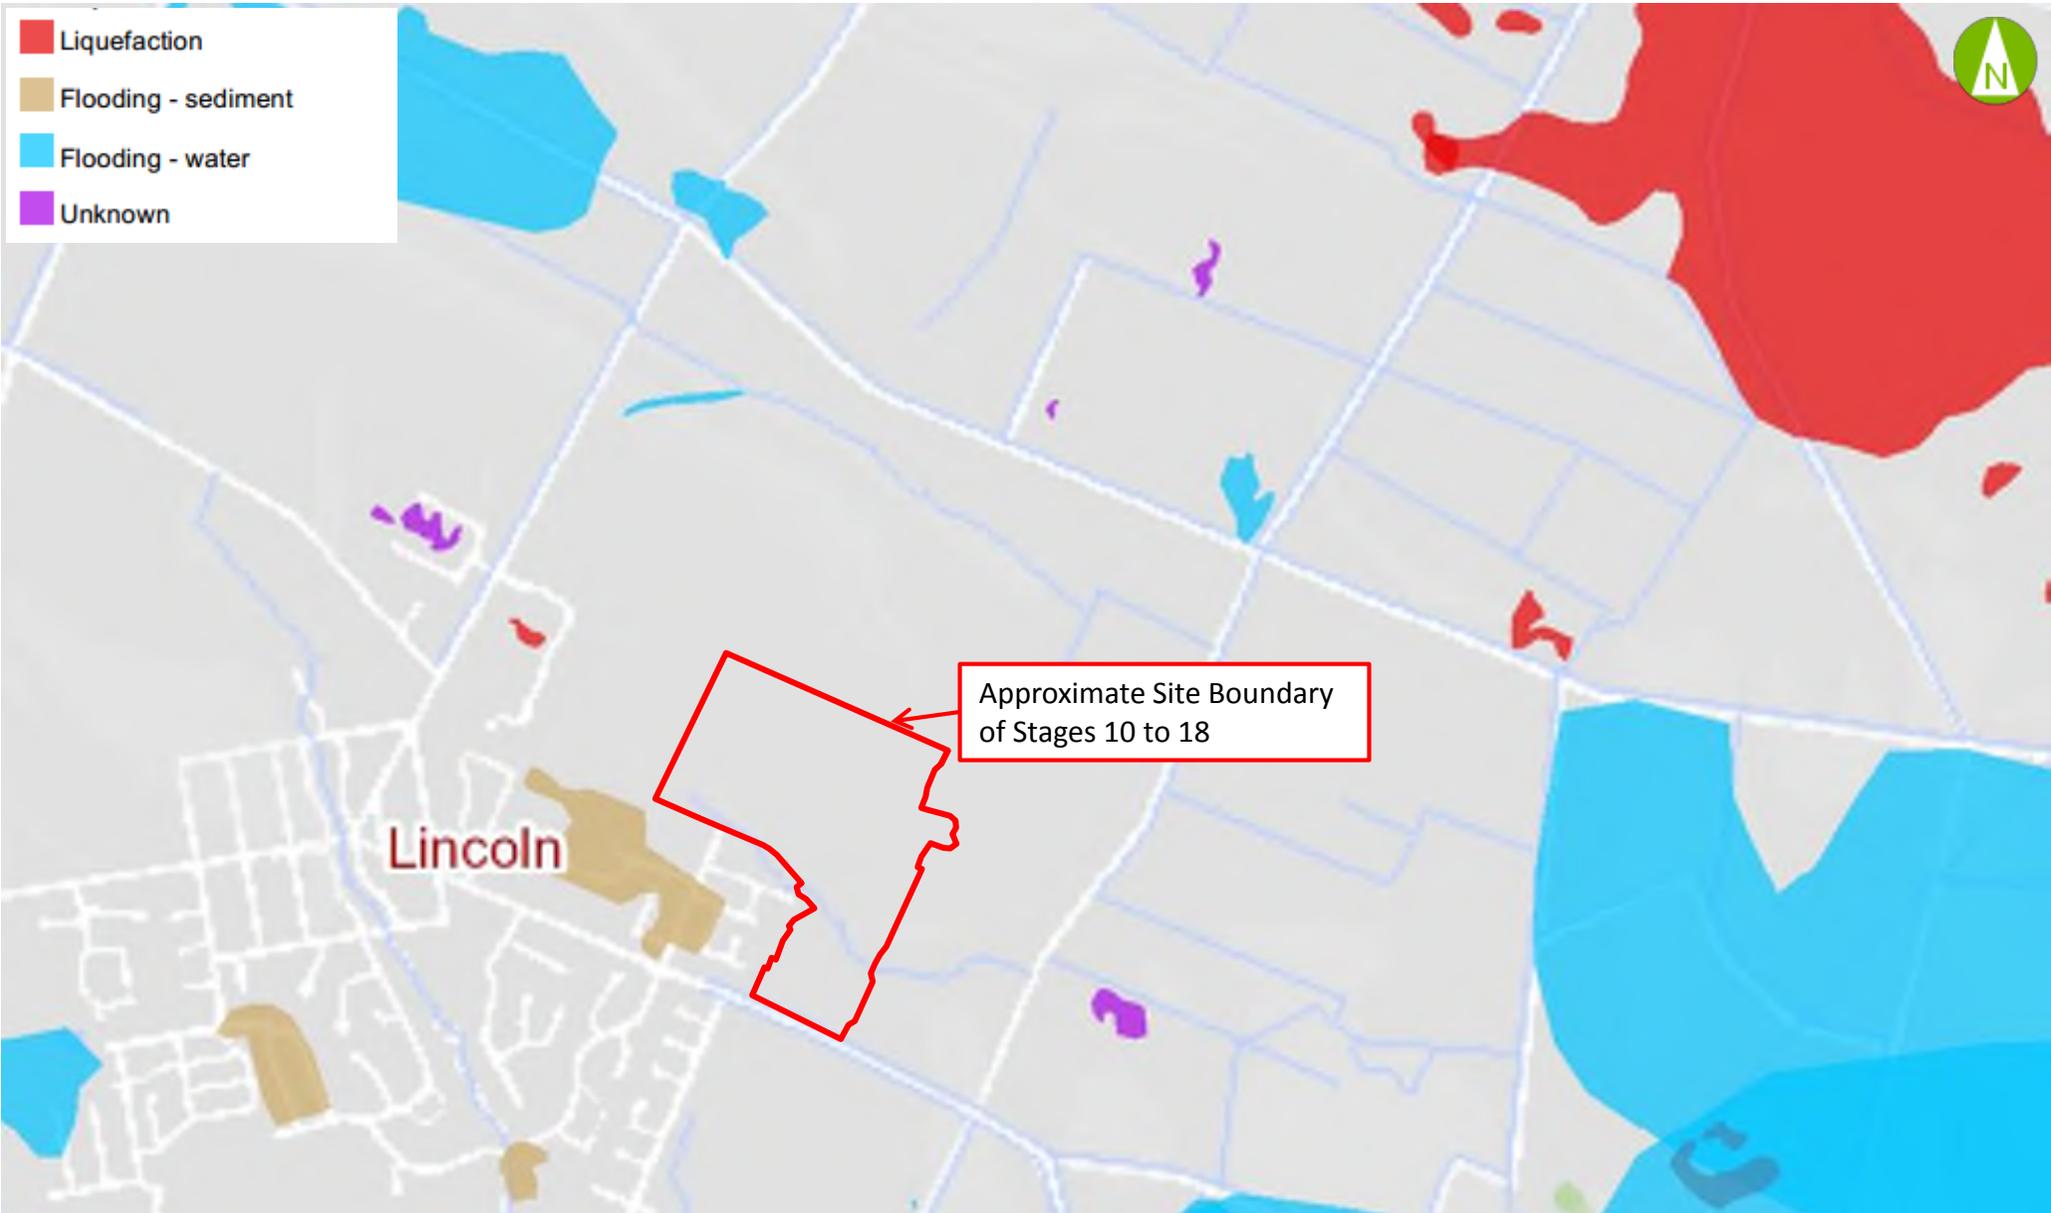
Approximate Site Boundary of Stages 10 to 18

- Liquefaction
- Flooding - sediment
- Flooding - water
- Unknown

Based on the GNS Science report “Review of liquefaction hazard information in eastern Canterbury, including Christchurch City and parts of Selwyn, Waimakariri and Hurunui” (GNS, 2012), as shown on Canterbury Maps (2015), there was no observed liquefaction induced damage after the 4 September 2010 or 22 February 2011 earthquakes. But there were minor observed areas within 500m of the site. The locations of observed damage are shown in Figures 3 and 4 in Appendix A.

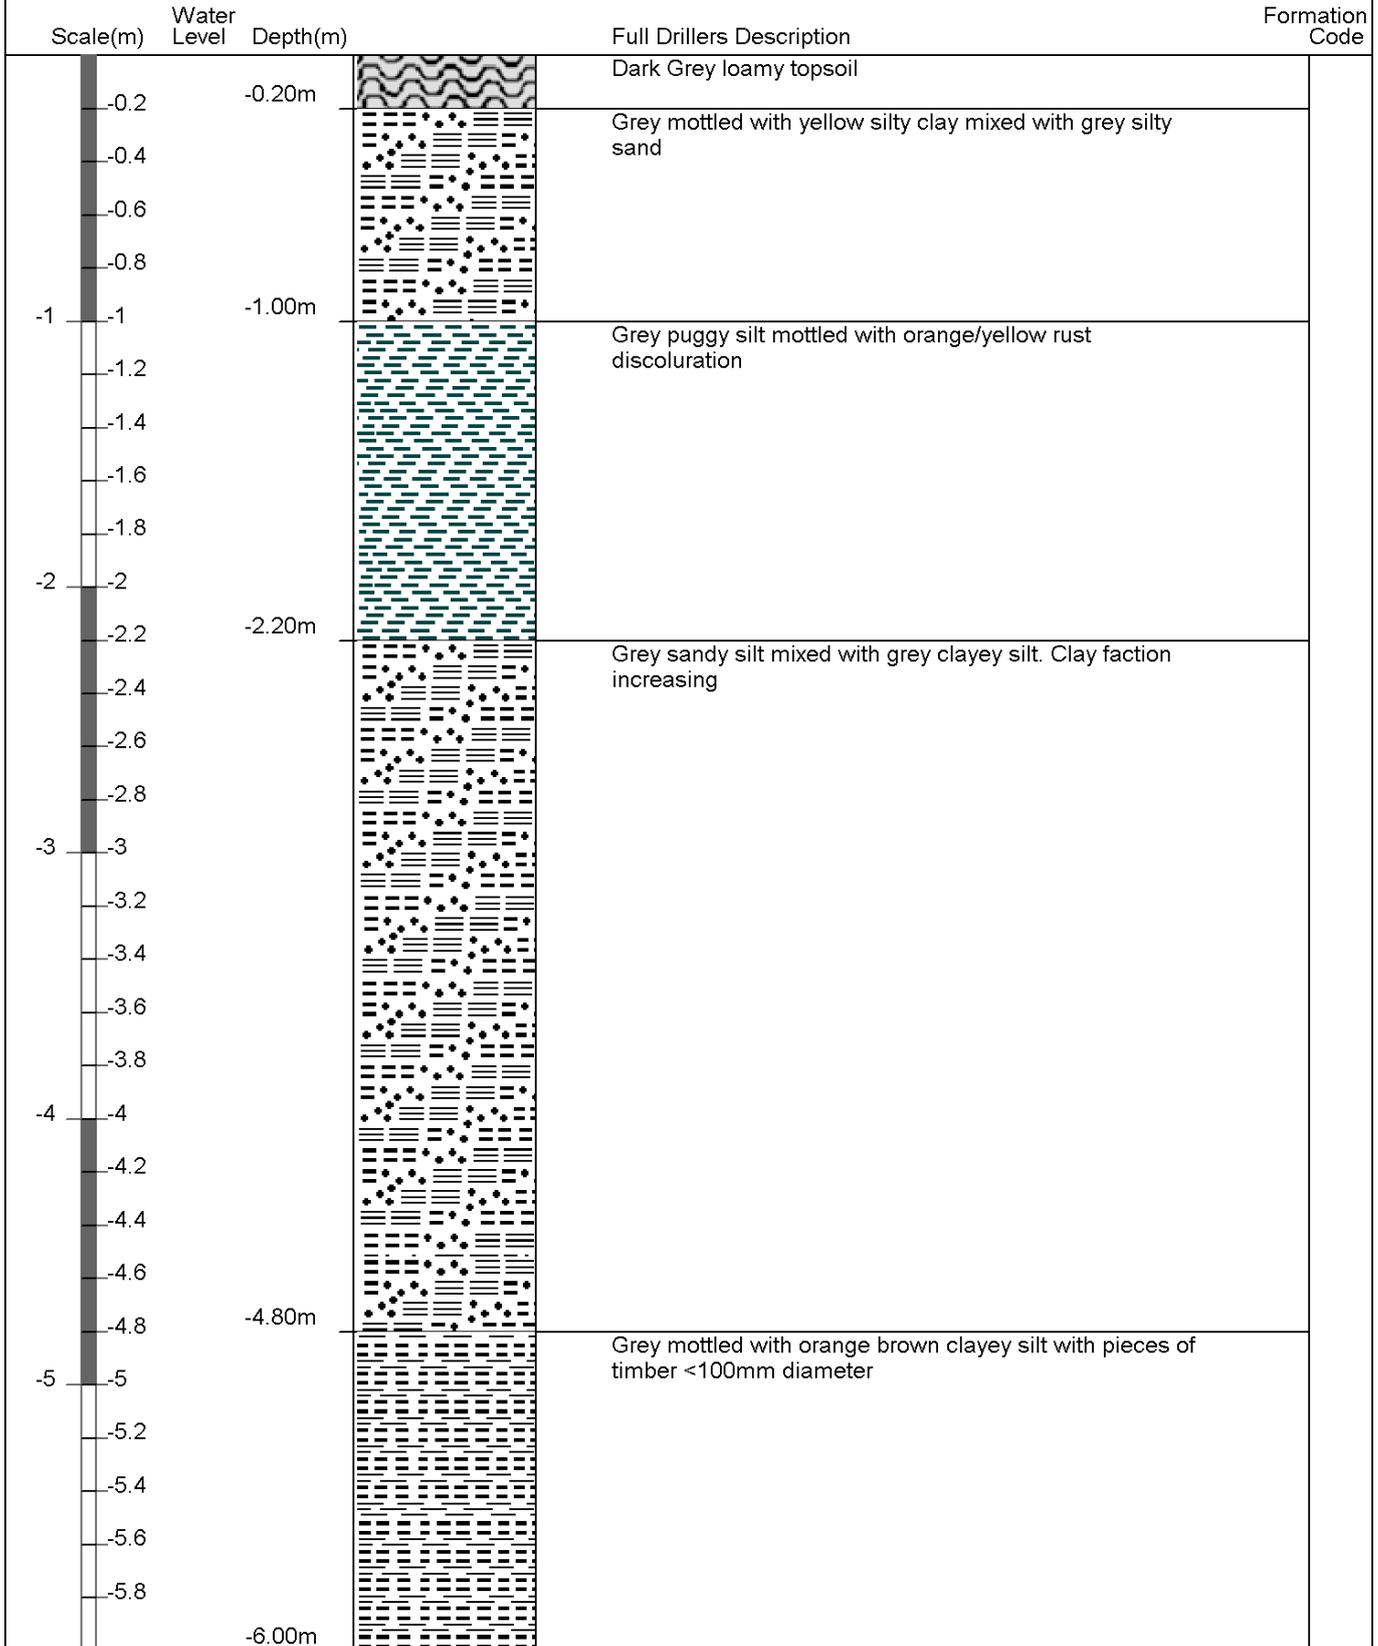
# Borelog for well M36/8673

Gridref: M36:69764-29180 Accuracy : 2 (1=high, 5=low)  
 Ground Level Altitude : 8.67 +MSD  
 Driller : not known  
 Drill Method : Rotary/Percussion  
 Drill Depth : -6m Drill Date : 9/10/2008

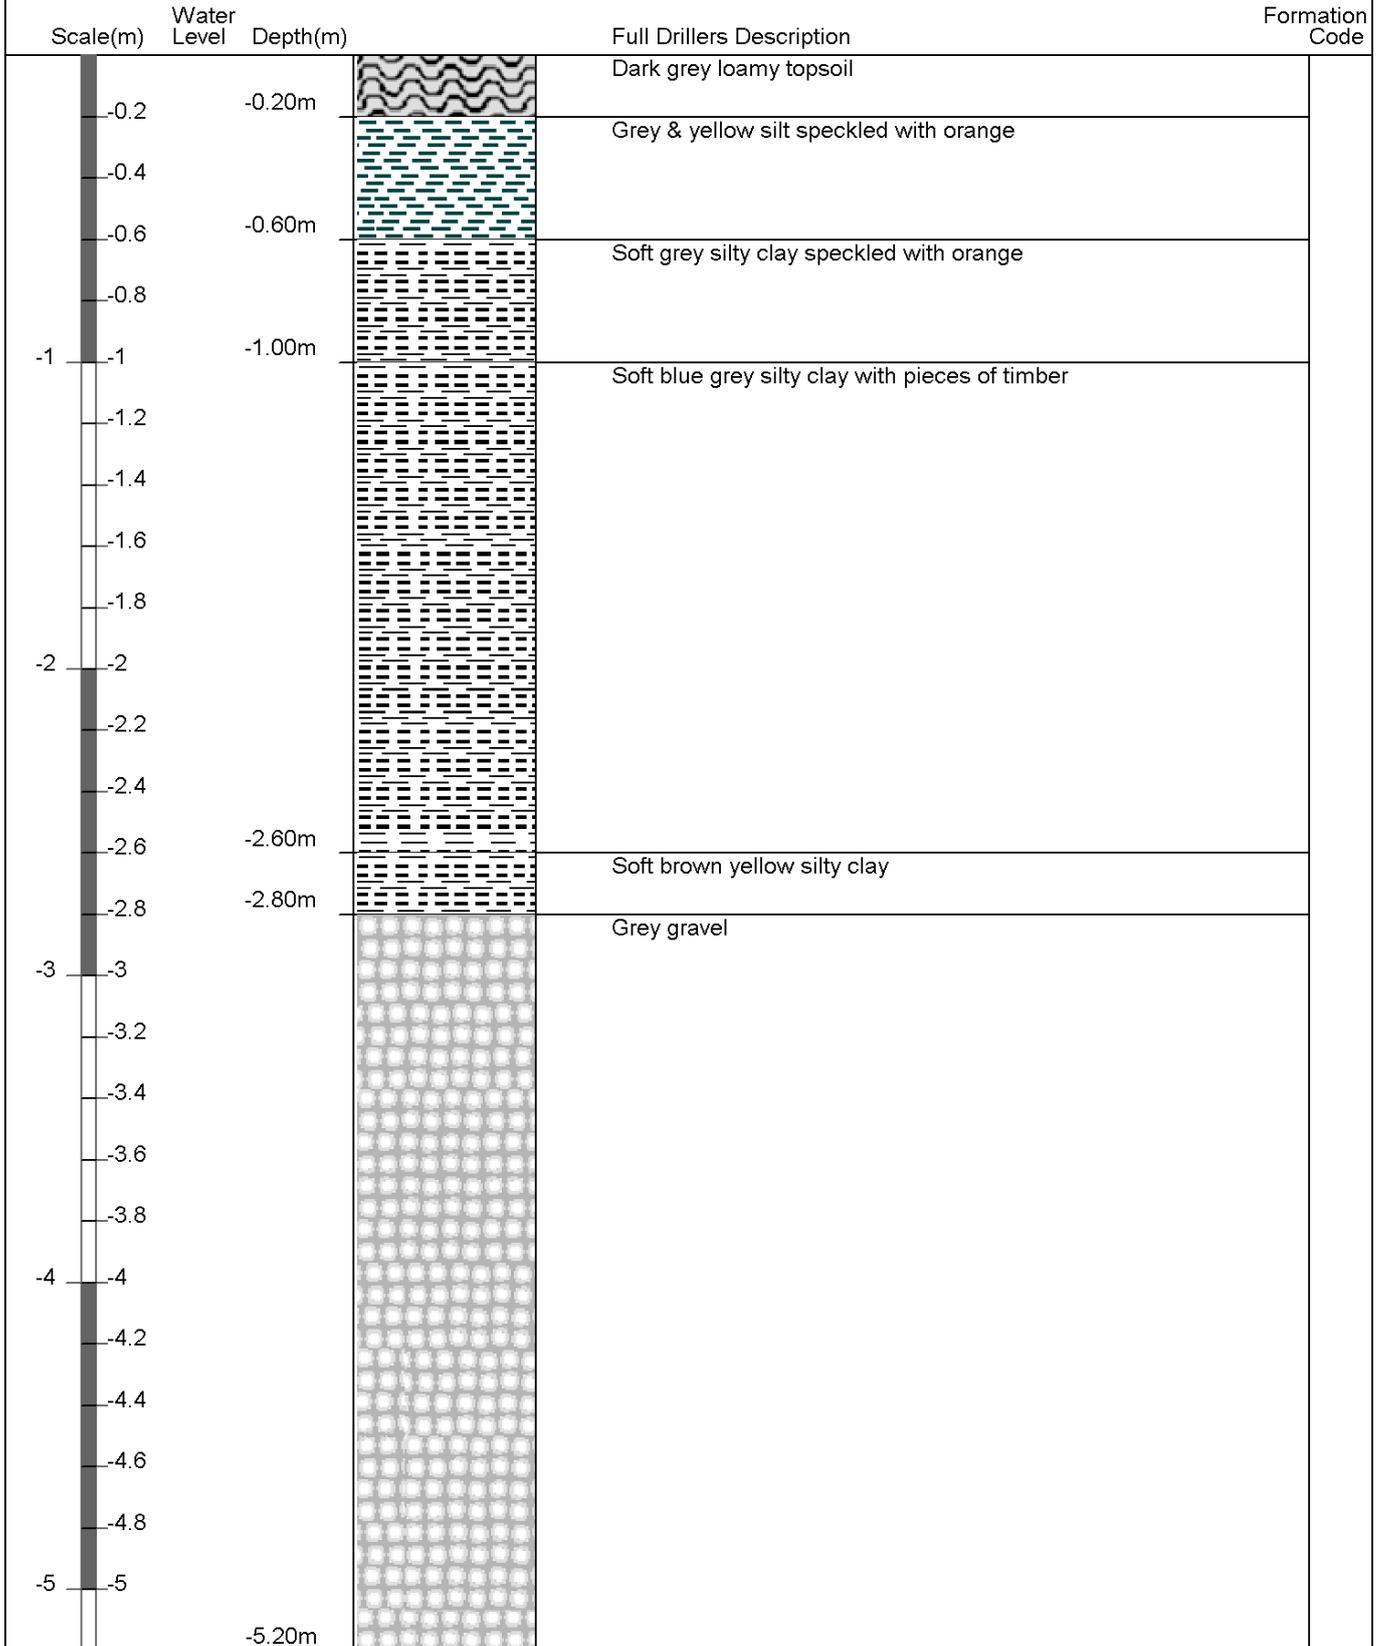
# Borelog for well M36/8678

Gridref: M36:69444-29810 Accuracy : 2 (1=high, 5=low)  
 Ground Level Altitude : 10.14 +MSD  
 Driller : not known  
 Drill Method : Rotary/Percussion  
 Drill Depth : -5.2m Drill Date : 9/10/2008

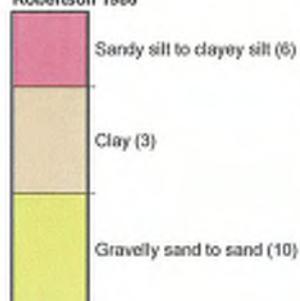
Location: Rosemarryn Subdivision	Position: X: 0.00 m, Y: 0.00 m	Ground level: 0.00	Test no: 1
Project ID:	Client: Aurecon	Date: 4/20/2012	Scale: 1 : 22
Project: ROSEMARRYN	Page: 1/2	Fig:	
File: RosemarrynSubdivisionCPT1.cpt

Classification by  
Robertson 1986

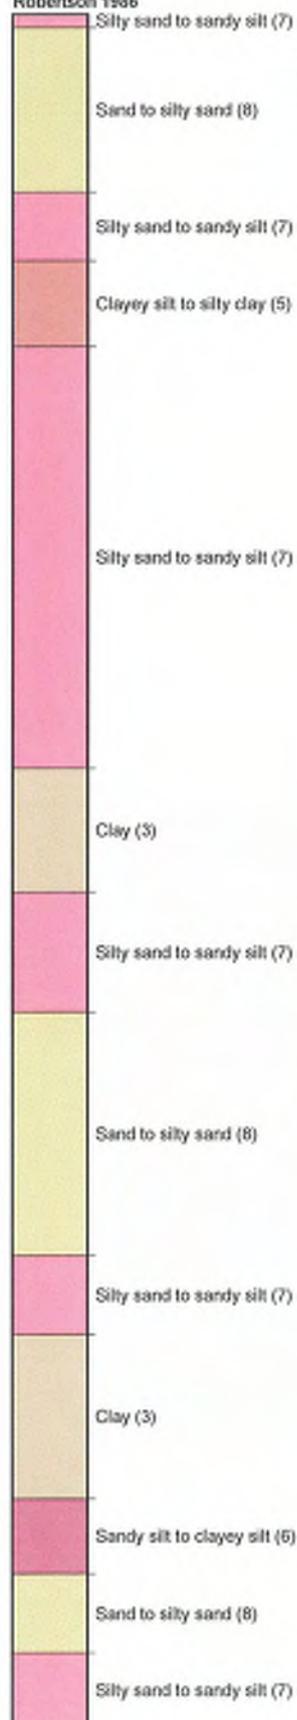
Location: Rosemarryn Subdivision	Position: X: 0.00 m, Y: 0.00 m	Ground level: 0.00	Test no: 6
Project ID:	Client: Aurecon	Date: 4/20/2012	Scale: 1 : 22
Project: ROSEMARRYN		Page: 3/3	Fig:
		File: RosemarrynSubdivisionCPT6.cpl

Classification by  
Robertson 1986

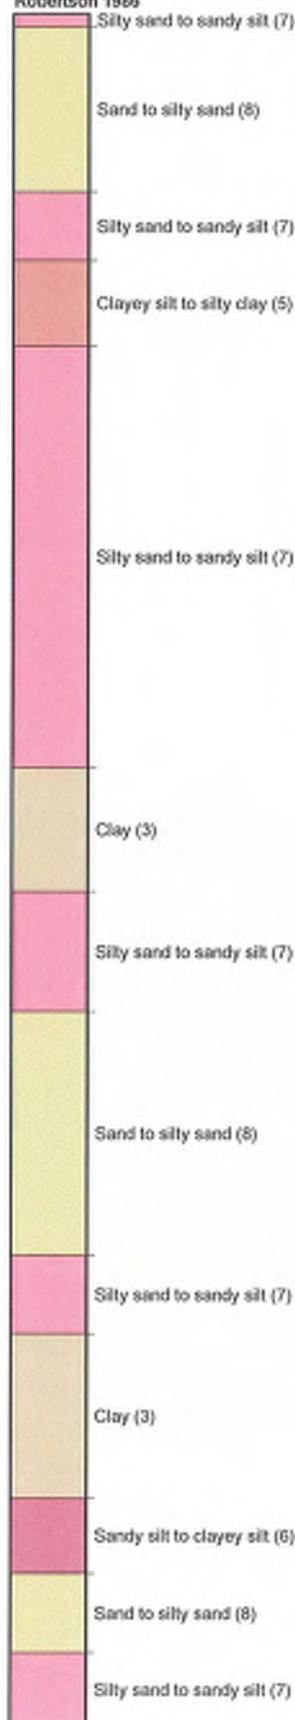
Location: Rosemarryn Subdivision	Position: X: 0.00 m, Y: 0.00 m	Ground level: 0.00	Test no: 8
Project ID:	Client: Aurecon	Date: 4/20/2012	Scale: 1 : 22
Project: ROSEMARRYN		Page: 2/2	Fig:
		File: RosemarrynSubdivisionCPT8.cpl

Classification by  
Robertson 1986

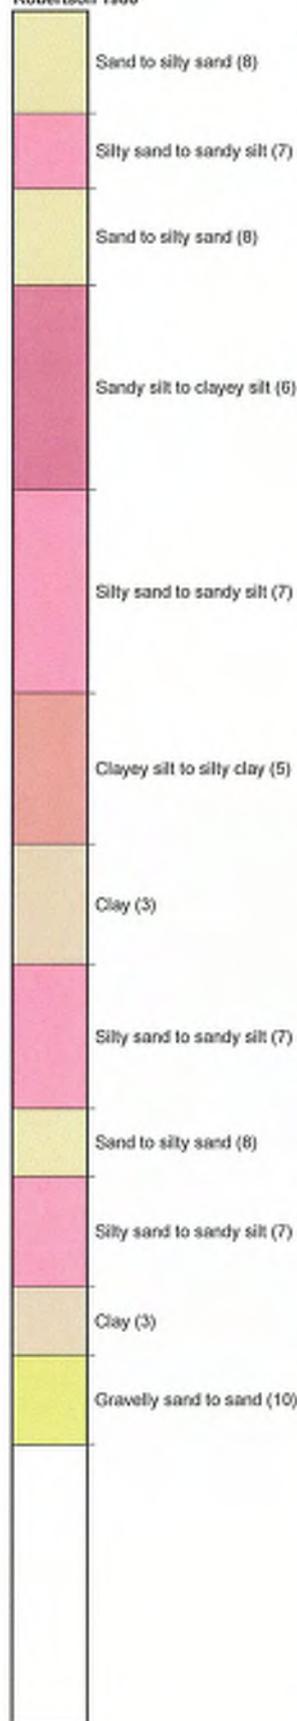
Location: Rosemarryn Subdivision	Position: X: 0.00 m, Y: 0.00 m	Ground level: 0.00	Test no: 8
Project ID:	Client: Aurecon	Date: 4/20/2012	Scale: 1 : 22
Project: ROSEMARRYN		Page: 2/2	Fig:
		File: RosemarrynSubdivisionCPT8.cpt

Classification by  
Robertson 1996

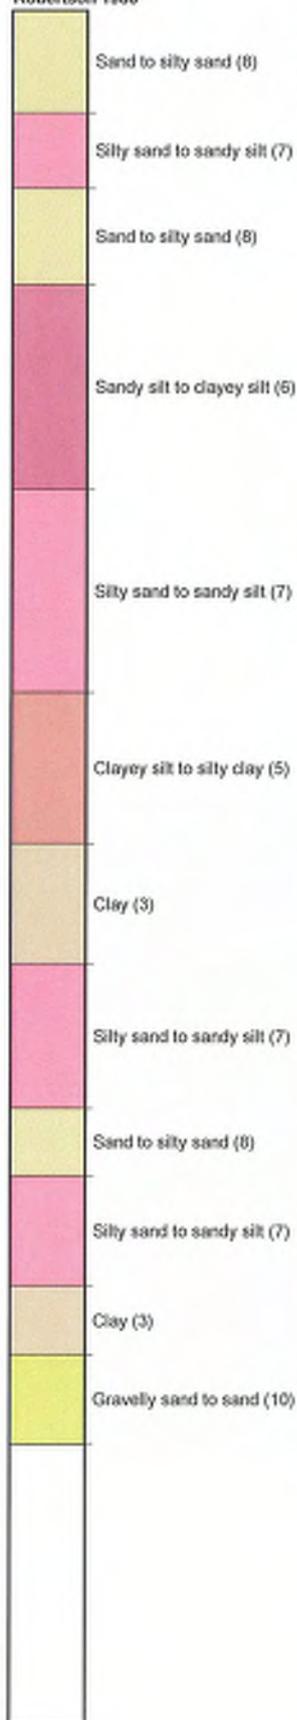
Location: Rosemarryn Subdivision	Position: X: 0.00 m, Y: 0.00 m	Ground level: 0.00	Test no: 9
Project ID:	Client: Aurecon	Date: 4/23/2012	Scale: 1 : 22
Project: ROSEMARRYN	Page: 1/1	Fig:	
File: RosemarrynSubdivisionCPT9.cpt

Classification by  
Robertson 1986

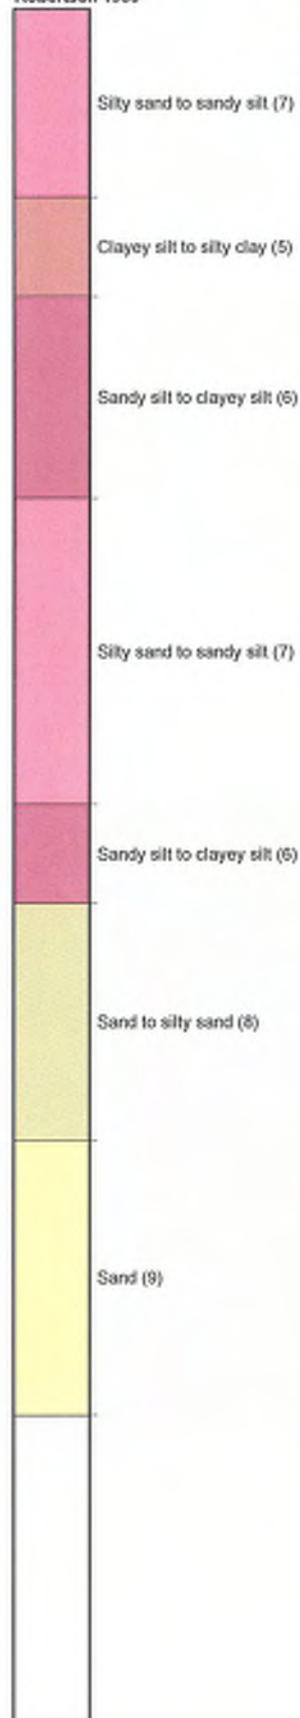
Location: Rosemarryn Subdivision	Position: X: 0.00 m, Y: 0.00 m	Ground level: 0.00	Test no: 10
Project ID:	Client: Aurecon	Date: 4/21/2012	Scale: 1 : 22
Project: ROSEMARRYN		Page: 1/1	Fig:
File: RosemarrynSubdivisionCPT10.cpt

Classification by  
Robertson 1986

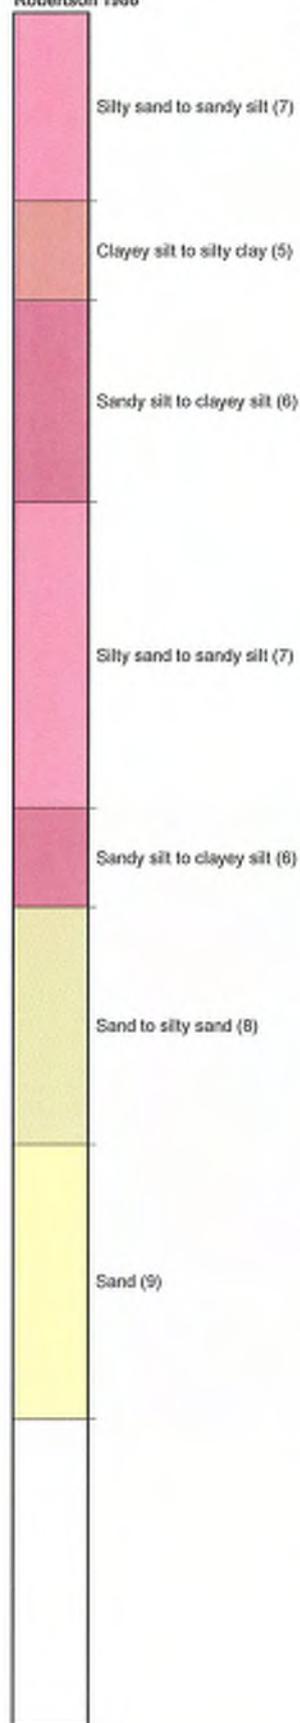
Location: Rosemarryn Subdivision	Position: X: 0.00 m, Y: 0.00 m	Ground level: 0.00	Test no: 11
Project ID:	Client: Aurecon	Date: 4/21/2012	Scale: 1 : 22
Project: ROSEMARRYN	Page: 1/1	Fig:	
File: RosemarrynSubdivisionCPT11.cp

Classification by  
Robertson 1986

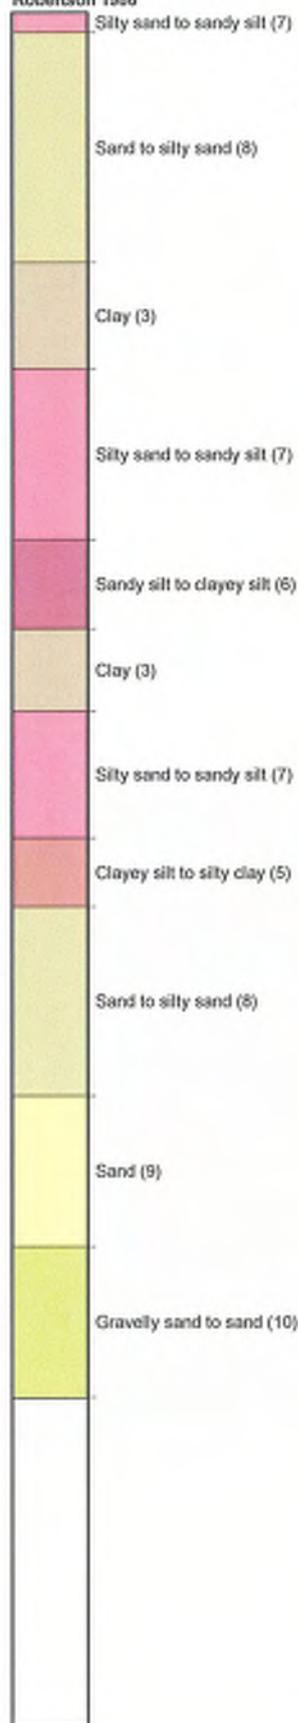
Location: Rosemarryn Subdivision	Position: X: 0.00 m, Y: 0.00 m	Ground level: 0.00	Test no: 12
Project ID:	Client: Aurecon	Date: 4/21/2012	Scale: 1 : 22
Project: ROSEMARRYN	Page: 1/1	Fig:	
File: RosemarrynSubdivisionCPT12.cp

Classification by  
Robertson 1986

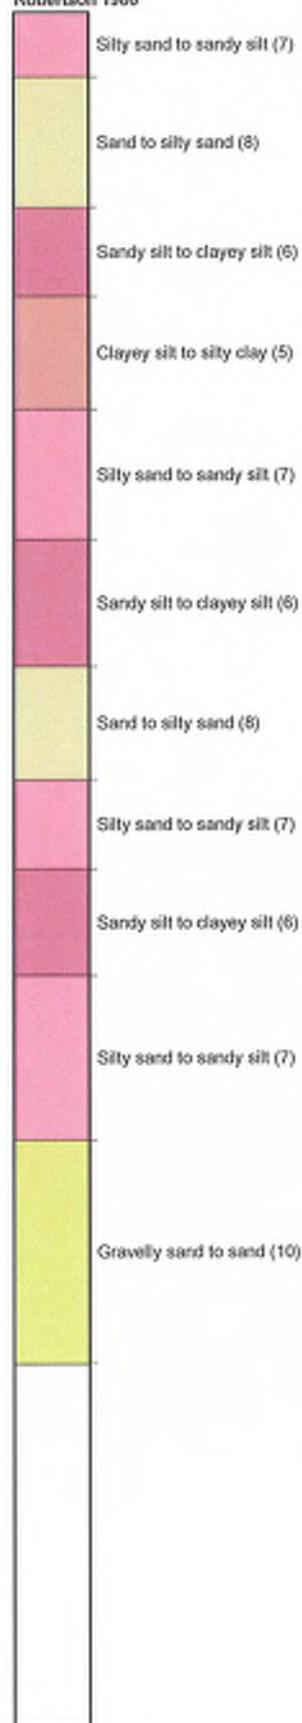
Location: Rosemarryn Subdivision	Position: X: 0.00 m, Y: 0.00 m	Ground level: 0.00	Test no: 14
Project ID:	Client: Aurecon	Date: 4/21/2012	Scale: 1 : 22
Project: ROSEMARRYN	Page: 1/1	Fig:	
File: RosemarrynSubdivisionCPT14.cpt

Classification by  
Robertson 1986

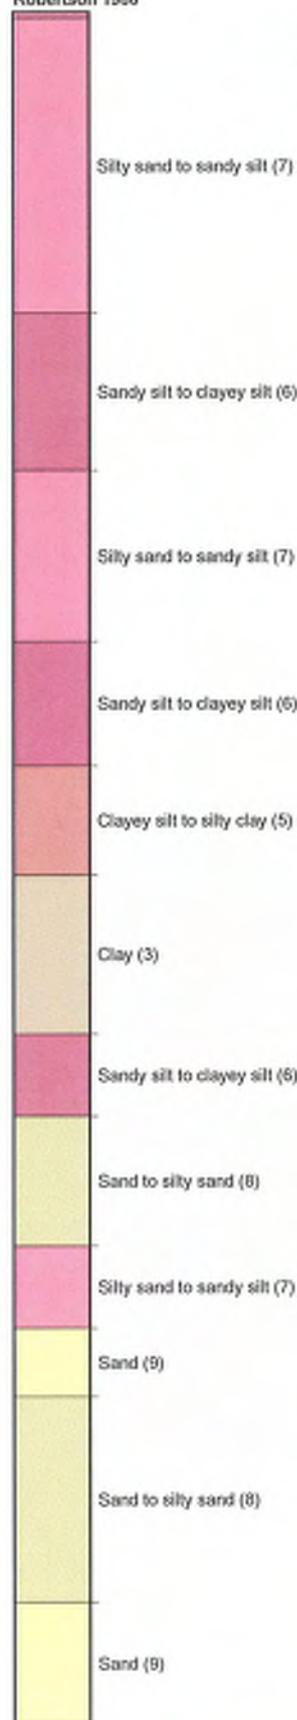
Location: Rosemarryn Subdivision	Position: X: 0.00 m, Y: 0.00 m	Ground level: 0.00	Test no: 15
Project ID:	Client: Aurecon	Date: 4/21/2012	Scale: 1 : 22
Project: ROSEMARRYN	Page: 2/2	Fig:	
File: RosemarrynSubdivisionCPT15.cp

Classification by  
Robertson 1986

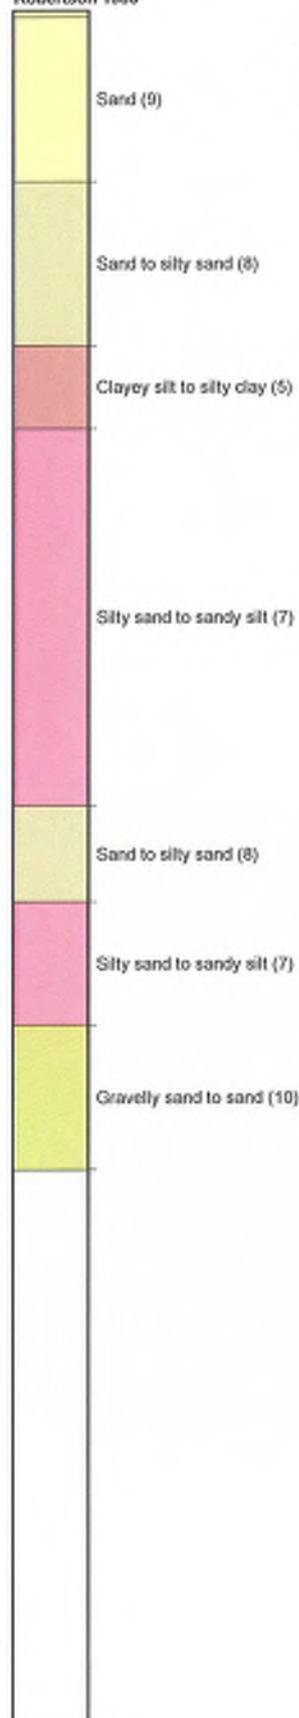
Location: Rosemarryn Subdivision	Position: X: 0.00 m, Y: 0.00 m	Ground level: 0.00	Test no: 16
Project ID:	Client: Aurecon	Date: 4/21/2013	Scale: 1 : 22
Project: ROSEMARRYN		Page: 1/1	Fig:
		File: RosemarrynSubdivisionCPT16.cp

Classification by  
Robertson 1986

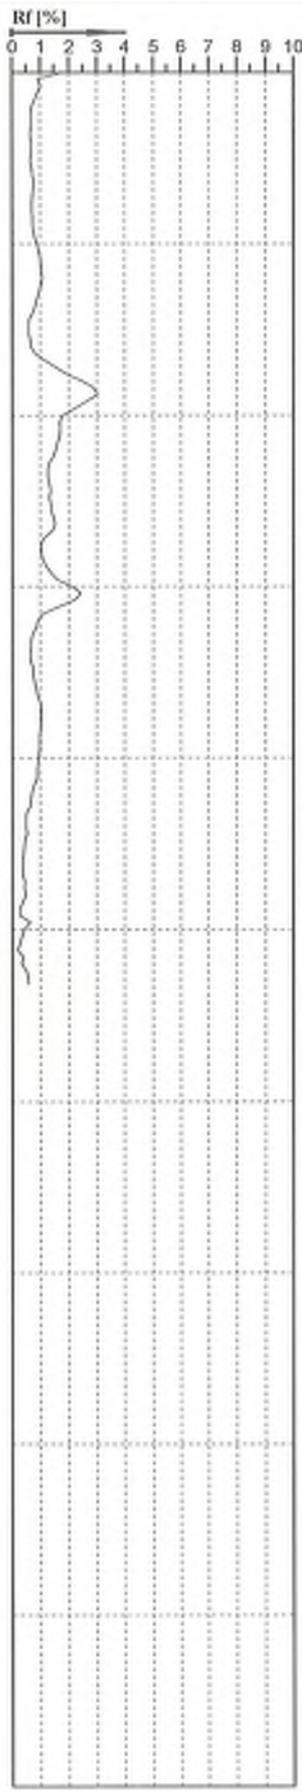
Classification by  
Robertson 1986

Silty sand to sandy silt (7)  
Sand to silty sand (8)  
Silty sand to sandy silt (7)  
Sandy silt to clayey silt (6)  
Silty sand to sandy silt (7)  
Sandy silt to clayey silt (6)

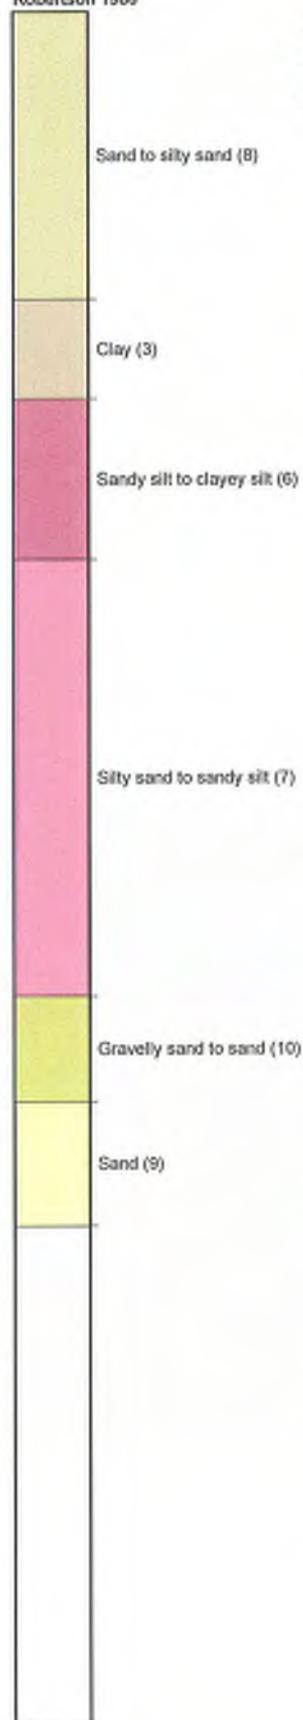
Location: Rosemarryn Subdivision	Position: X: 0.00 m, Y: 0.00 m	Ground level: 0.00	Test no: 18
Project ID:	Client: Aurecon	Date: 4/21/2013	Scale: 1 : 22
Project: ROSEMARRYN	Page: 1/1	Fig:	
File: RosemarrynSubdivisionCPT18.cp

Classification by  
Robertson 1986

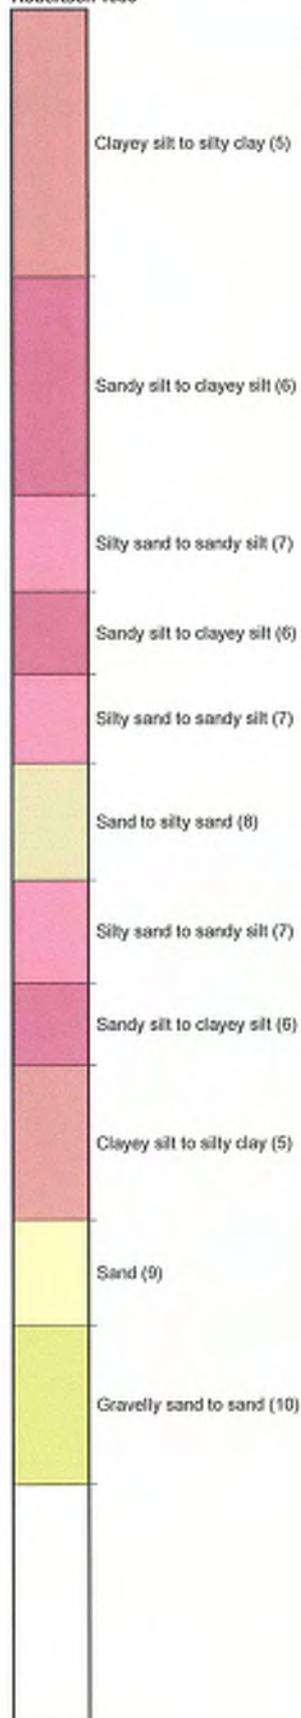
Location: Rosemarryn Subdivision	Position: X: 0.00 m, Y: 0.00 m	Ground level: 0.00	Test no: CPT25
Project ID:	Client: Aurecon	Date: 4/23/2012	Scale: 1 : 22
Project: ROSEMARRYN		Page: 1/1	Fig:
		File: RosemarrynSubdivisionCPT25.cpt

Classification by  
Robertson 1986

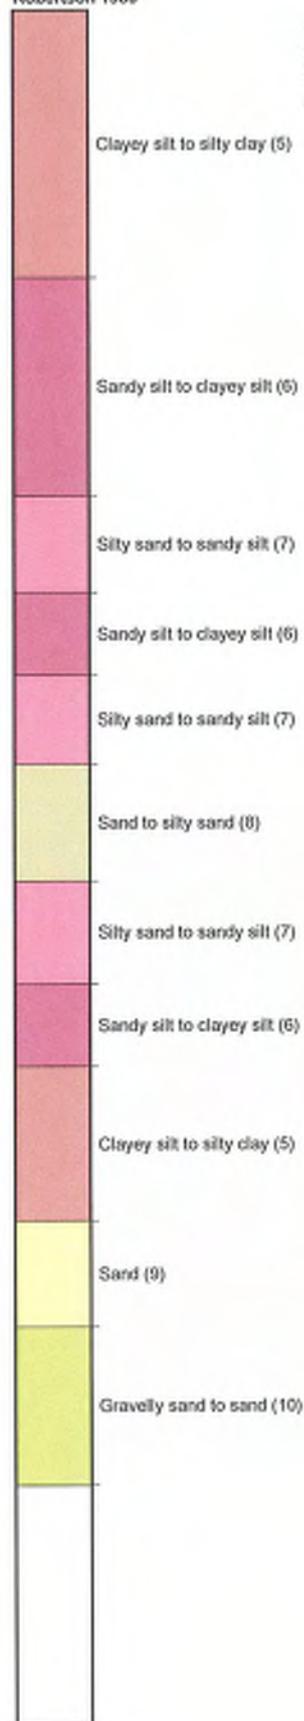
Location: Rosemarryn Subdivision	Position: X: 0.00 m, Y: 0.00 m	Ground level: 0.00	Test no: 27
Project ID:	Client: Aurecon	Date: 4/20/2012	Scale: 1 : 22
Project: ROSEMARRYN	Page: 1/1	Fig:	
File: RosemarrynSubdivisionCPT27.cp

Classification by  
Robertson 1986

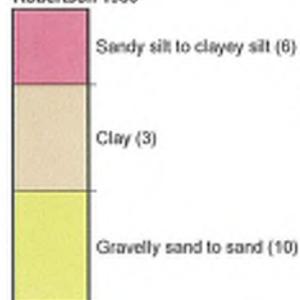
Location: Rosemarryn Subdivision	Position: X: 0.00 m, Y: 0.00 m	Ground level: 0.00	Test no: 1
Project ID:	Client: Aurecon	Date: 4/20/2012	Scale: 1 : 22
Project: ROSEMARRYN	Page: 1/2	Fig:	
File: RosemarrynSubdivisionCPT1.cpt

Classification by  
Robertson 1986

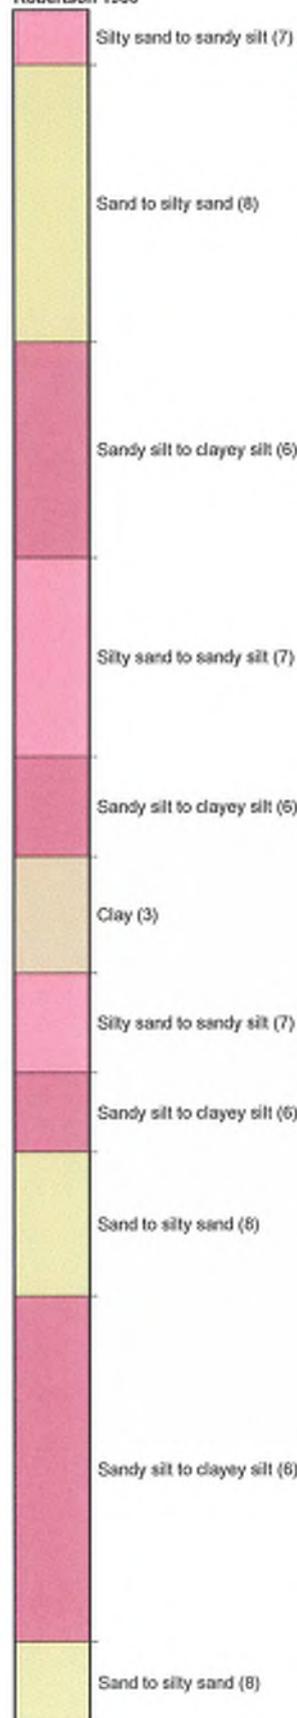
Location: Rosemarryn Subdivision	Position: X: 0.00 m, Y: 0.00 m	Ground level: 0.00	Test no: 2
Project ID:	Client: Aurecon	Date: 4/20/2012	Scale: 1 : 22
Project: ROSEMARRYN		Page: 2/2	Fig:
File: RosemarrynSubdivisionCPT2.cpt

Classification by  
Robertson 1986

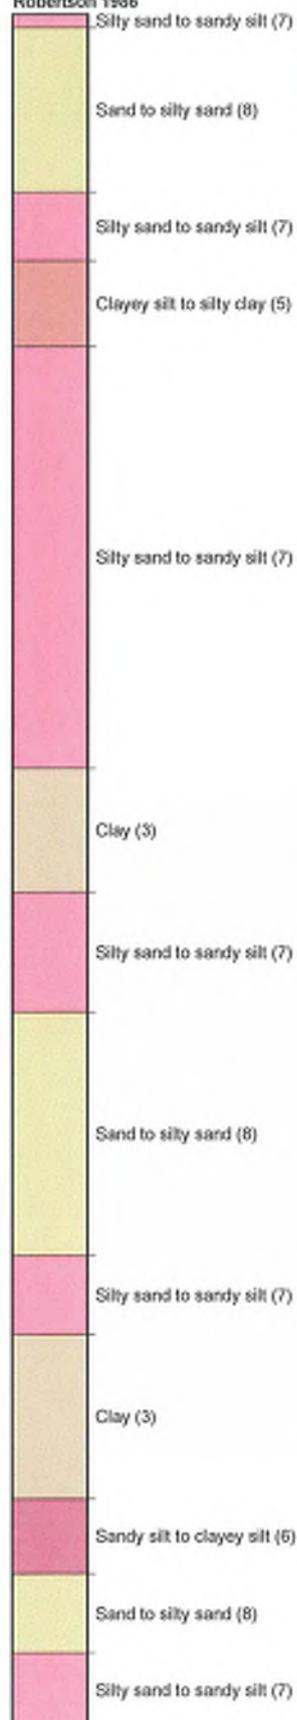
Location: Rosemarryn Subdivision	Position: X: 0.00 m, Y: 0.00 m	Ground level: 0.00	Test no: 6
Project ID:	Client: Aurecon	Date: 4/20/2012	Scale: 1 : 22
Project: ROSEMARRYN		Page: 3/3	Fig:
		File: RosemarrynSubdivisionCPT6.cpt

Classification by  
Robertson 1986

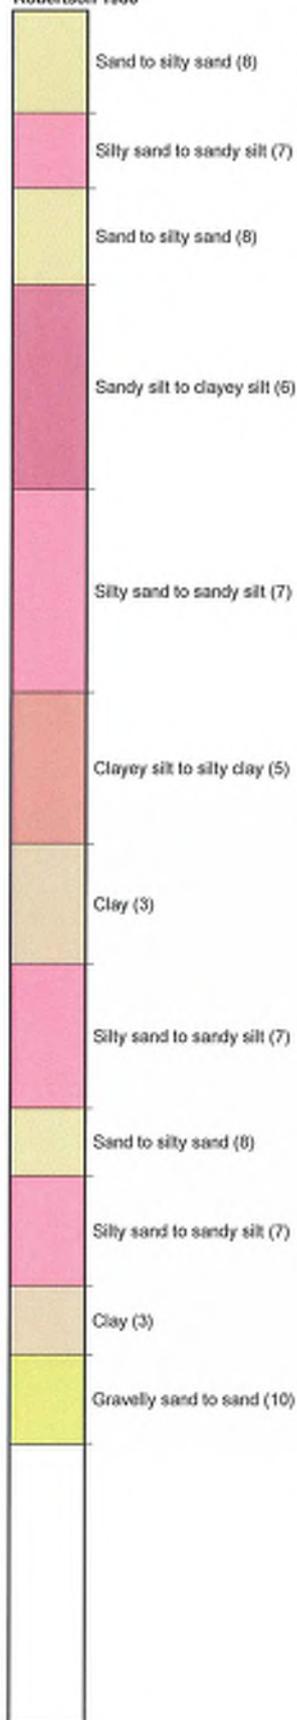
Location: Rosemarryn Subdivision	Position: X: 0.00 m, Y: 0.00 m	Ground level: 0.00	Test no: 9
Project ID:	Client: Aurecon	Date: 4/23/2012	Scale: 1 : 22
Project: ROSEMARRYN	Page: 1/1	Fig:	
File: RosemarrynSubdivisionCPT9.cpt

Classification by  
Robertson 1986

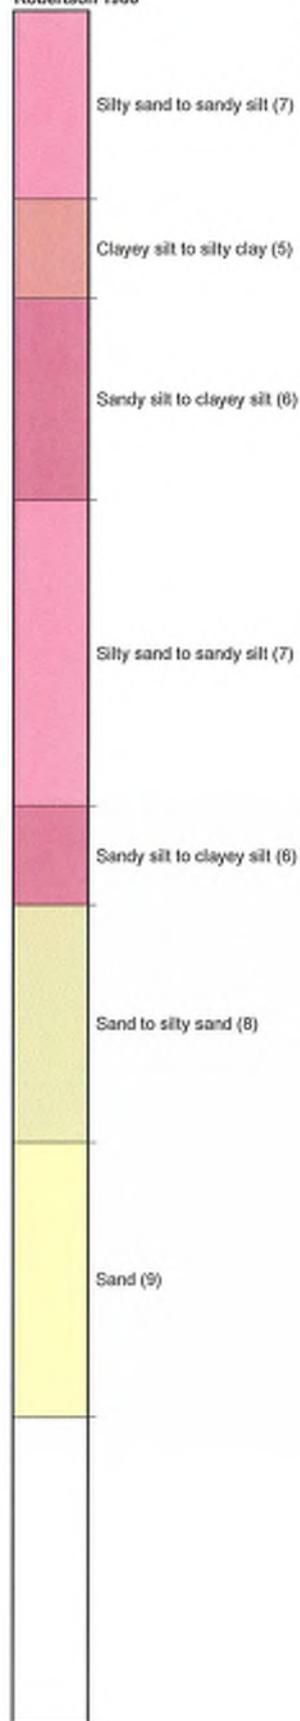
Location: Rosemarryn Subdivision	Position: X: 0.00 m, Y: 0.00 m	Ground level: 0.00	Test no: 11
Project ID:	Client: Aurecon	Date: 4/21/2012	Scale: 1 : 22
Project: ROSEMARRYN	Page: 1/1	Fig:	
File: RosemarrynSubdivisionCPT11.cp

Classification by  
Robertson 1986

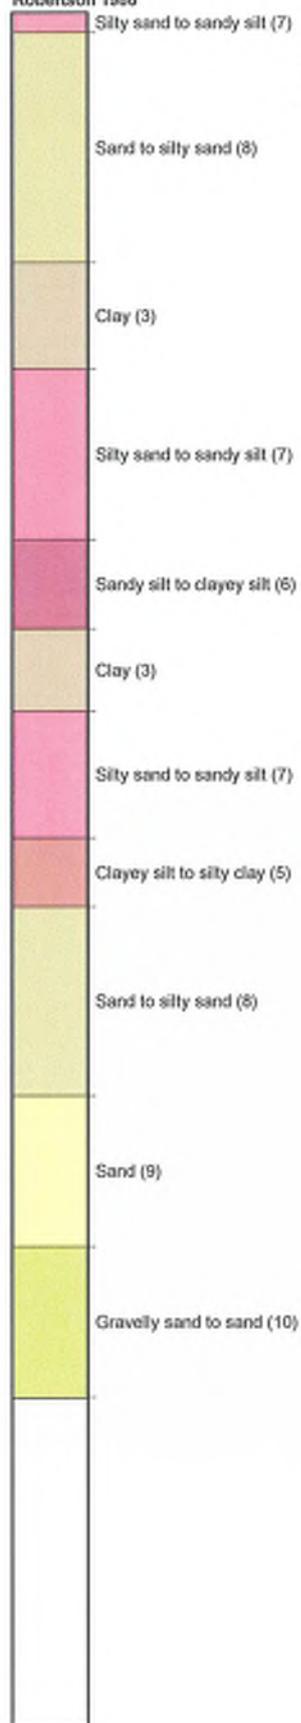
Location: Rosemarryn Subdivision	Position: X: 0.00 m, Y: 0.00 m	Ground level: 0.00	Test no: 12
Project ID:	Client: Aurecon	Date: 4/21/2012	Scale: 1 : 22
Project: ROSEMARRYN		Page: 1/1	Fig:
File: RosemarrynSubdivisionCPT12.cp

Classification by  
Robertson 1986

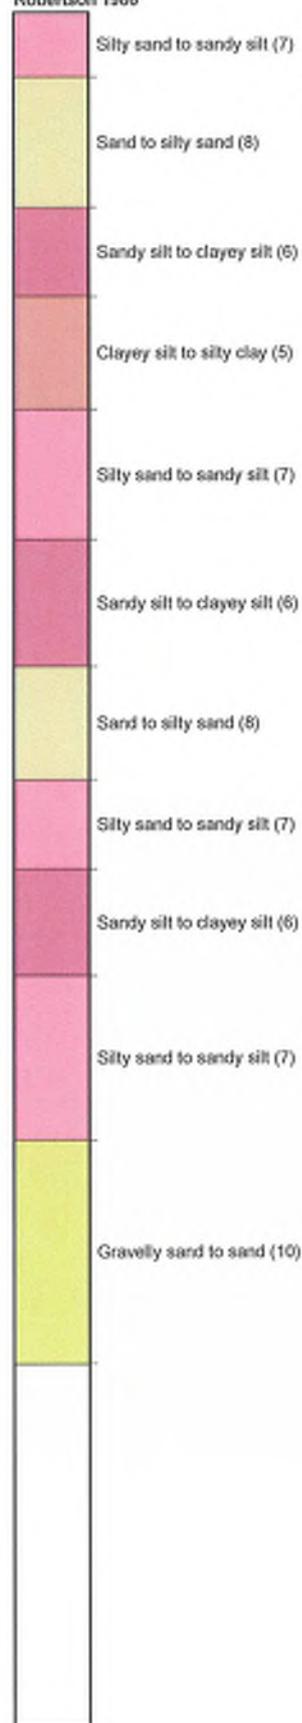
Location: Rosemarryn Subdivision	Position: X: 0.00 m, Y: 0.00 m	Ground level: 0.00	Test no: 14
Project ID:	Client: Aurecon	Date: 4/21/2012	Scale: 1 : 22
Project: ROSEMARRYN	Page: 1/1	Fig:	
File: RosemarrynSubdivisionCPT14.cpt

Classification by  
Robertson 1986

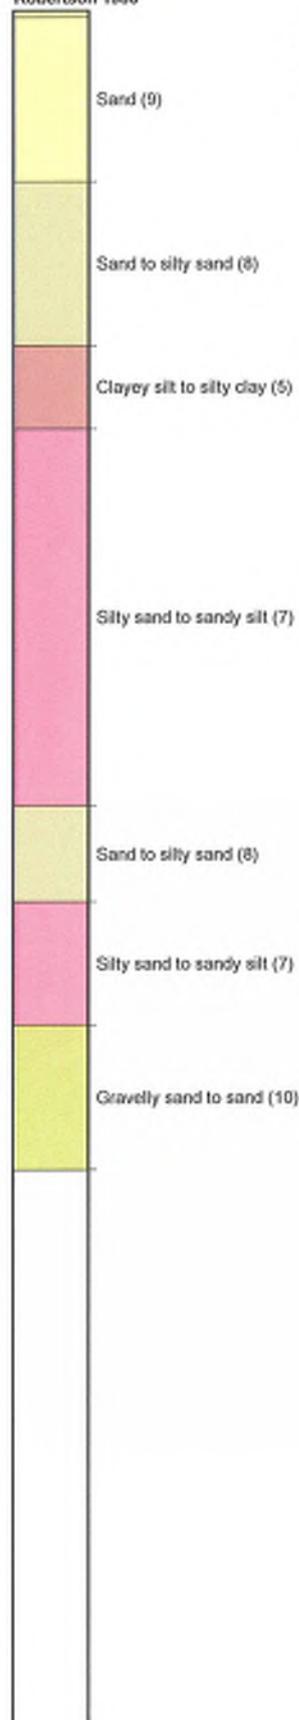
Location: Rosemarryn Subdivision	Position: X: 0.00 m, Y: 0.00 m	Ground level: 0.00	Test no: 16
Project ID:	Client: Aurecon	Date: 4/21/2013	Scale: 1 : 22
Project: ROSEMARRYN		Page: 1/1	Fig:
		File: RosemarrynSubdivisionCPT16.cp

Classification by  
Robertson 1986

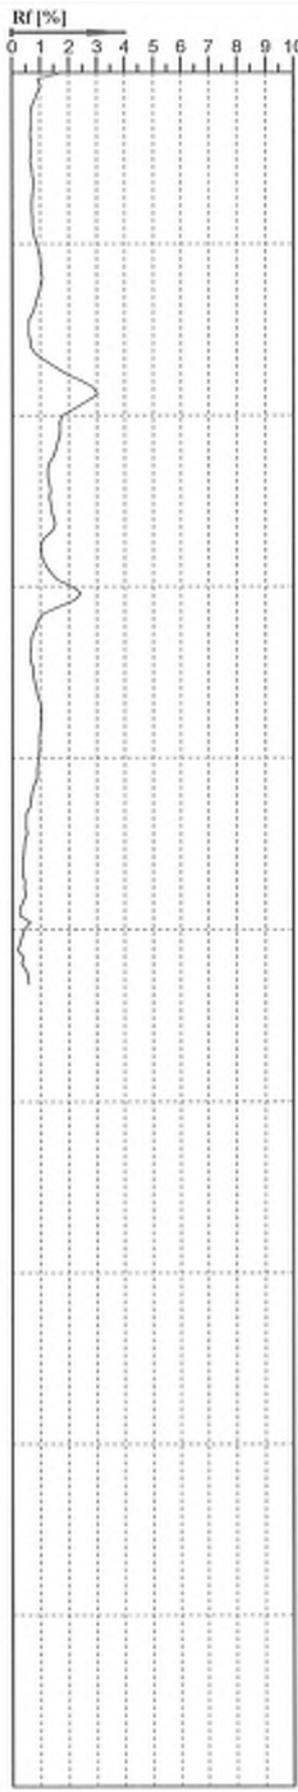
Classification by  
Robertson 1986

Silty sand to sandy silt (7)  
Sand to silty sand (8)  
Silty sand to sandy silt (7)  
Sandy silt to clayey silt (6)  
Silty sand to sandy silt (7)  
Sandy silt to clayey silt (6)

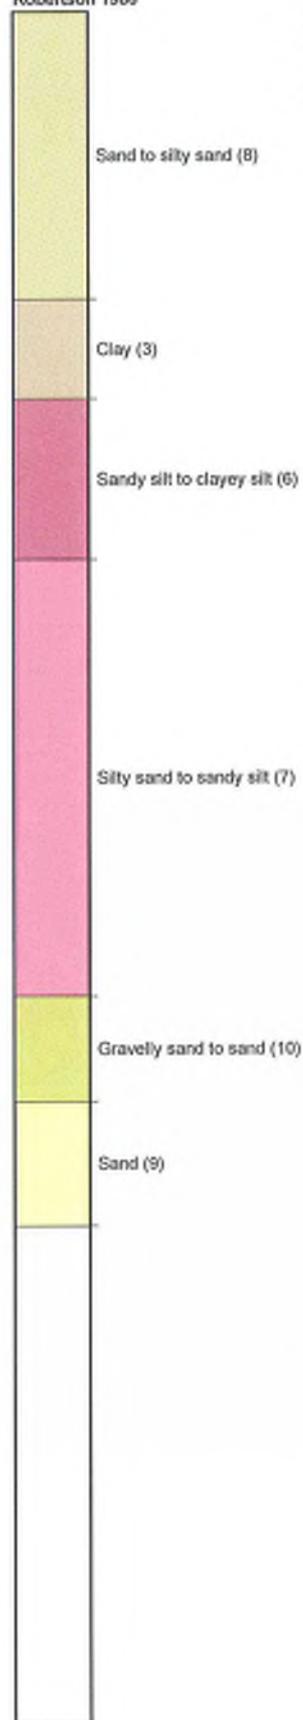
Location: Rosemarryn Subdivision	Position: X: 0.00 m, Y: 0.00 m	Ground level: 0.00	Test no: 18
Project ID:	Client: Aurecon	Date: 4/21/2013	Scale: 1 : 22
Project: ROSEMARRYN	Page: 1/1	Fig:	
File: RosemarrynSubdivisionCPT18.cp

Classification by  
Robertson 1986

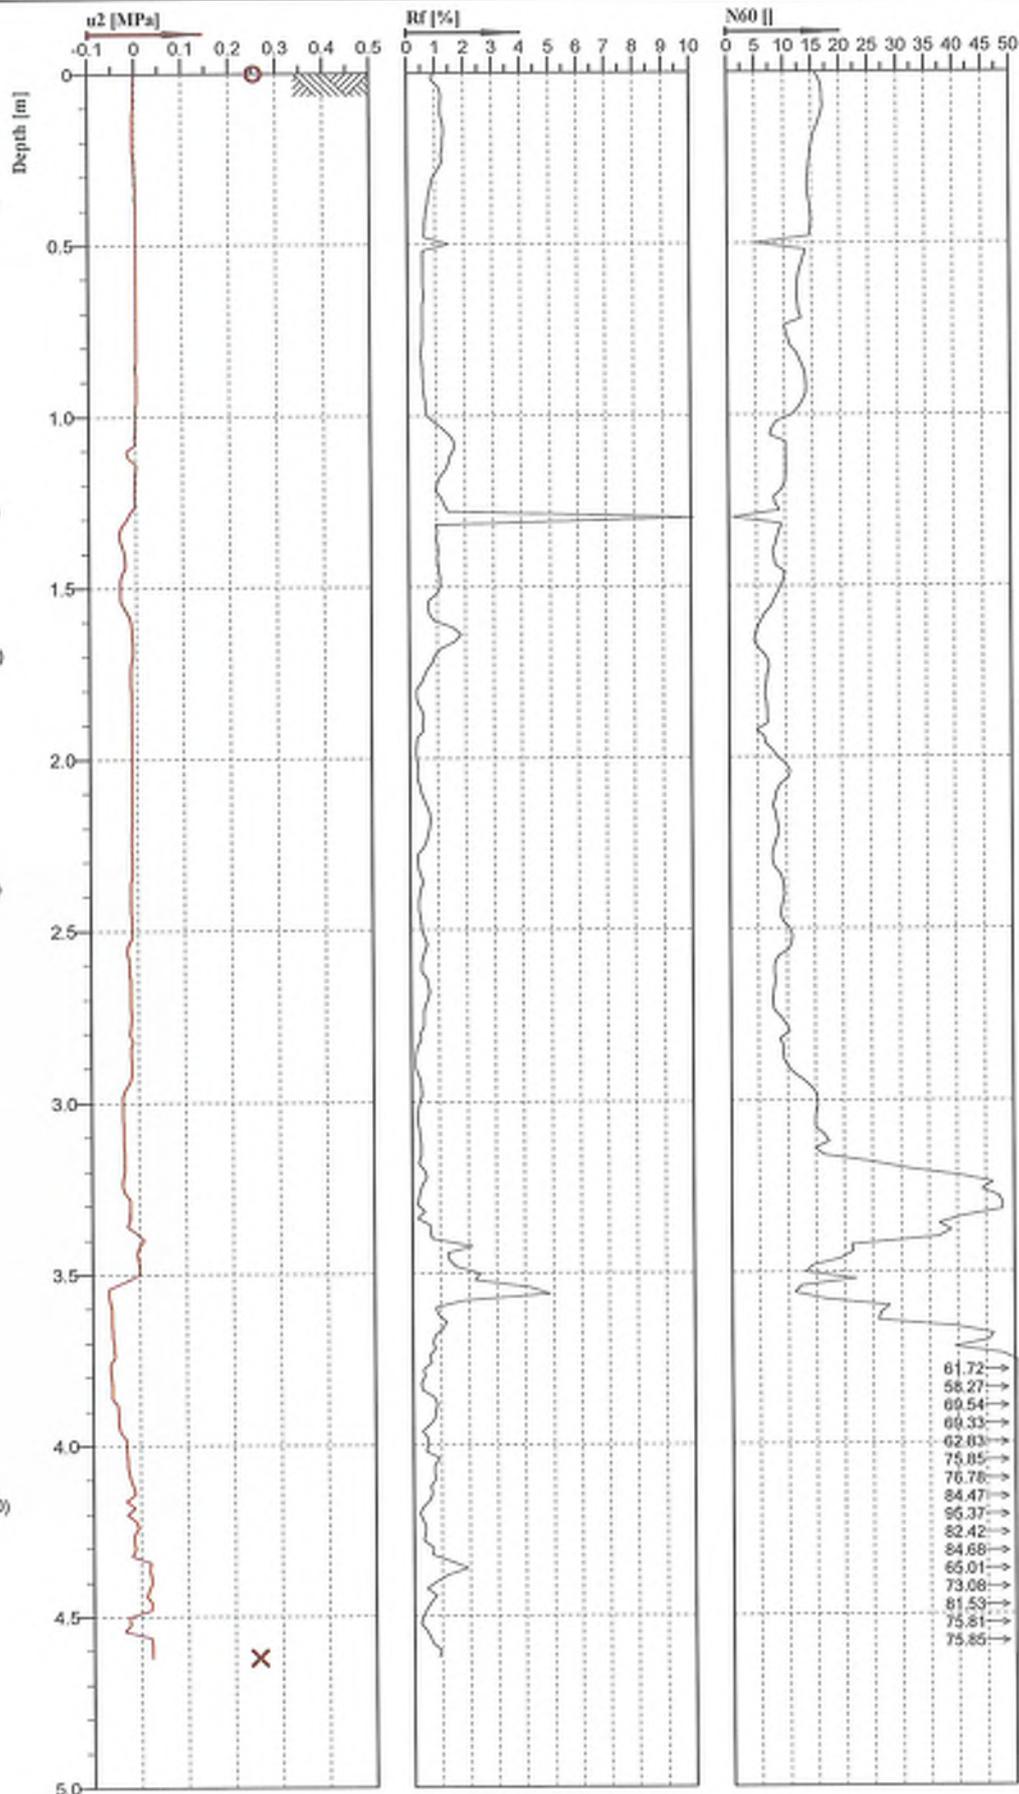
Location: Rosemarryn Subdivision	Position: X: 0.00 m, Y: 0.00 m	Ground level: 0.00	Test no: 22
Project ID:	Client: Aurecon	Date: 4/23/2012	Scale: 1 : 22
Project: ROSEMARRYN		Page: 1/1	Fig:
		File: RosemarrynSubdivisionCPT22.cp

Classification by  
Robertson 1986
