**Rosemerryn Subdivision, Lincoln**

Stages 10 to 18 Geotechnical  
Investigation Report

**Fulton Hogan Land Development  
Limited**

25 September 2015

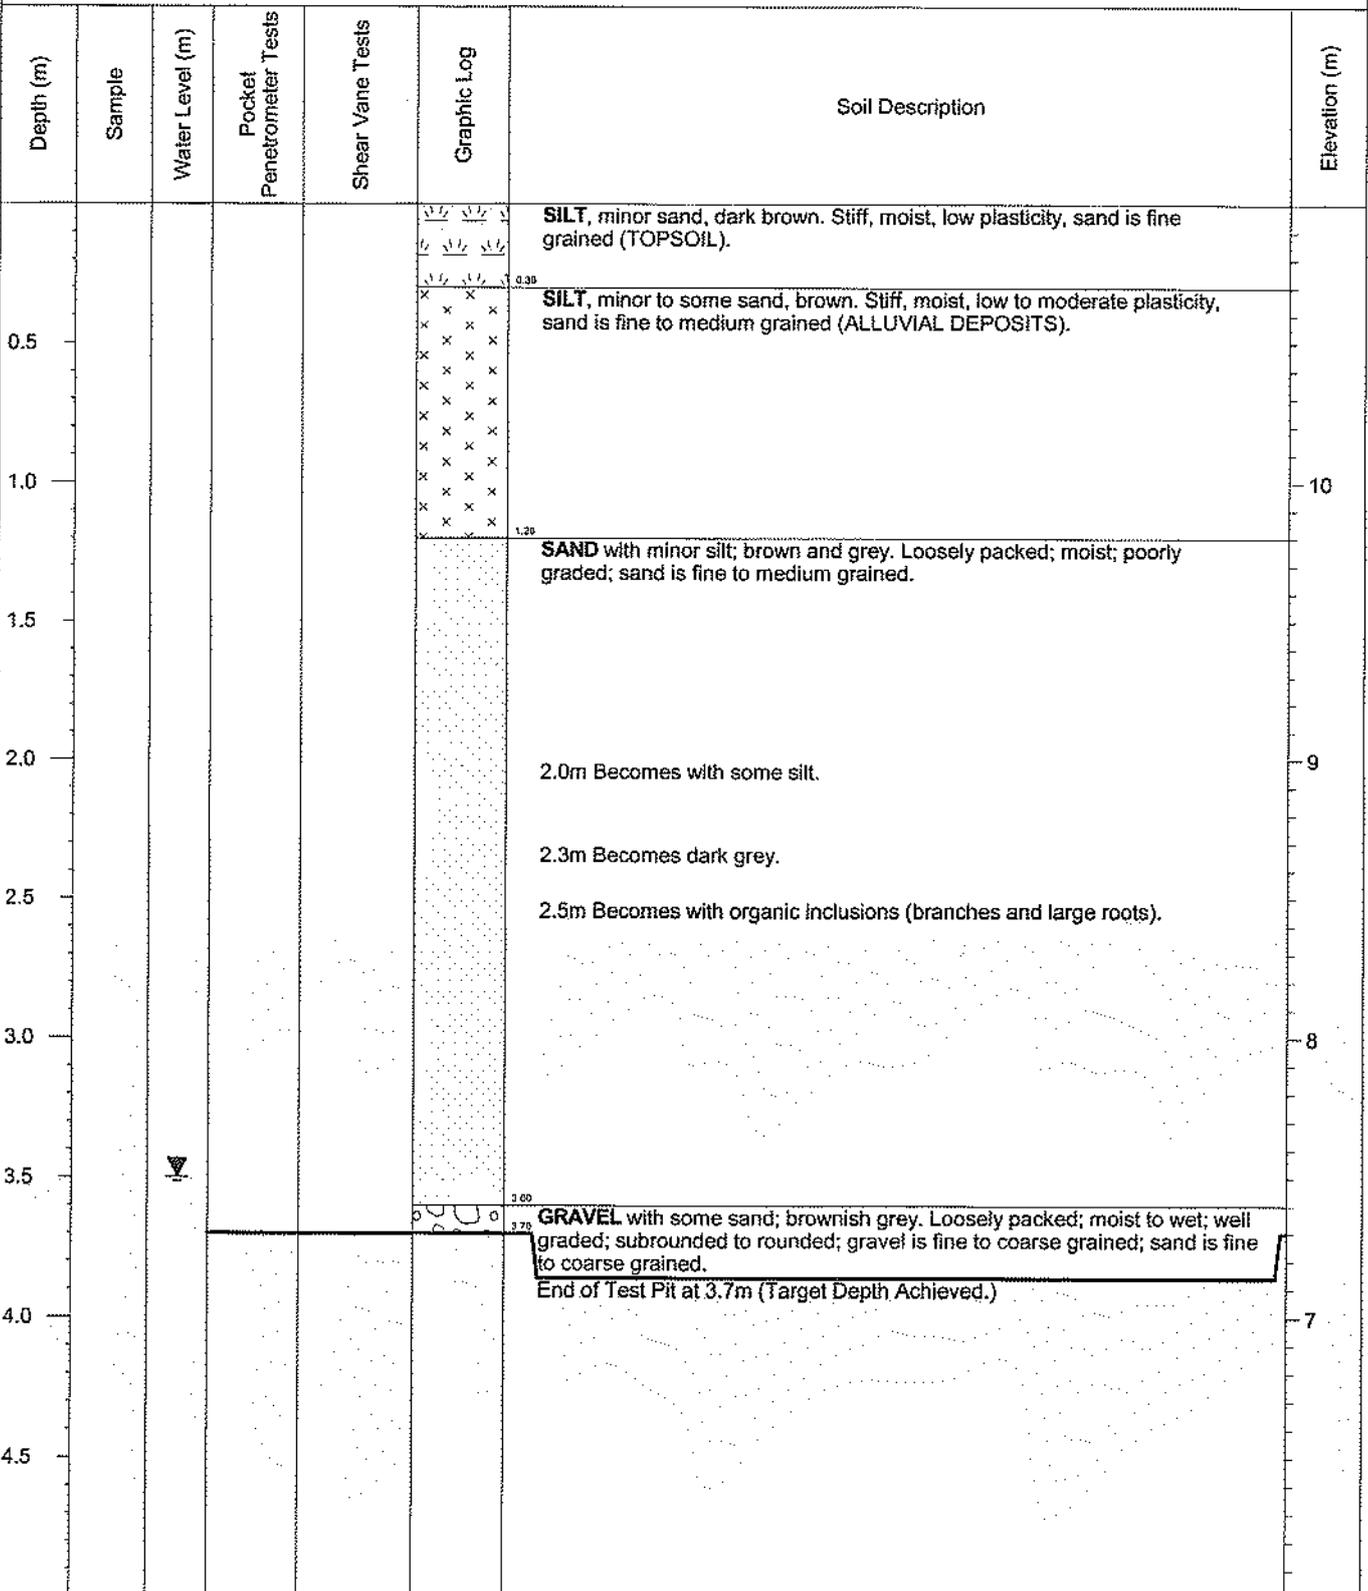
Remarks:  
 Groundwater at 3.5m

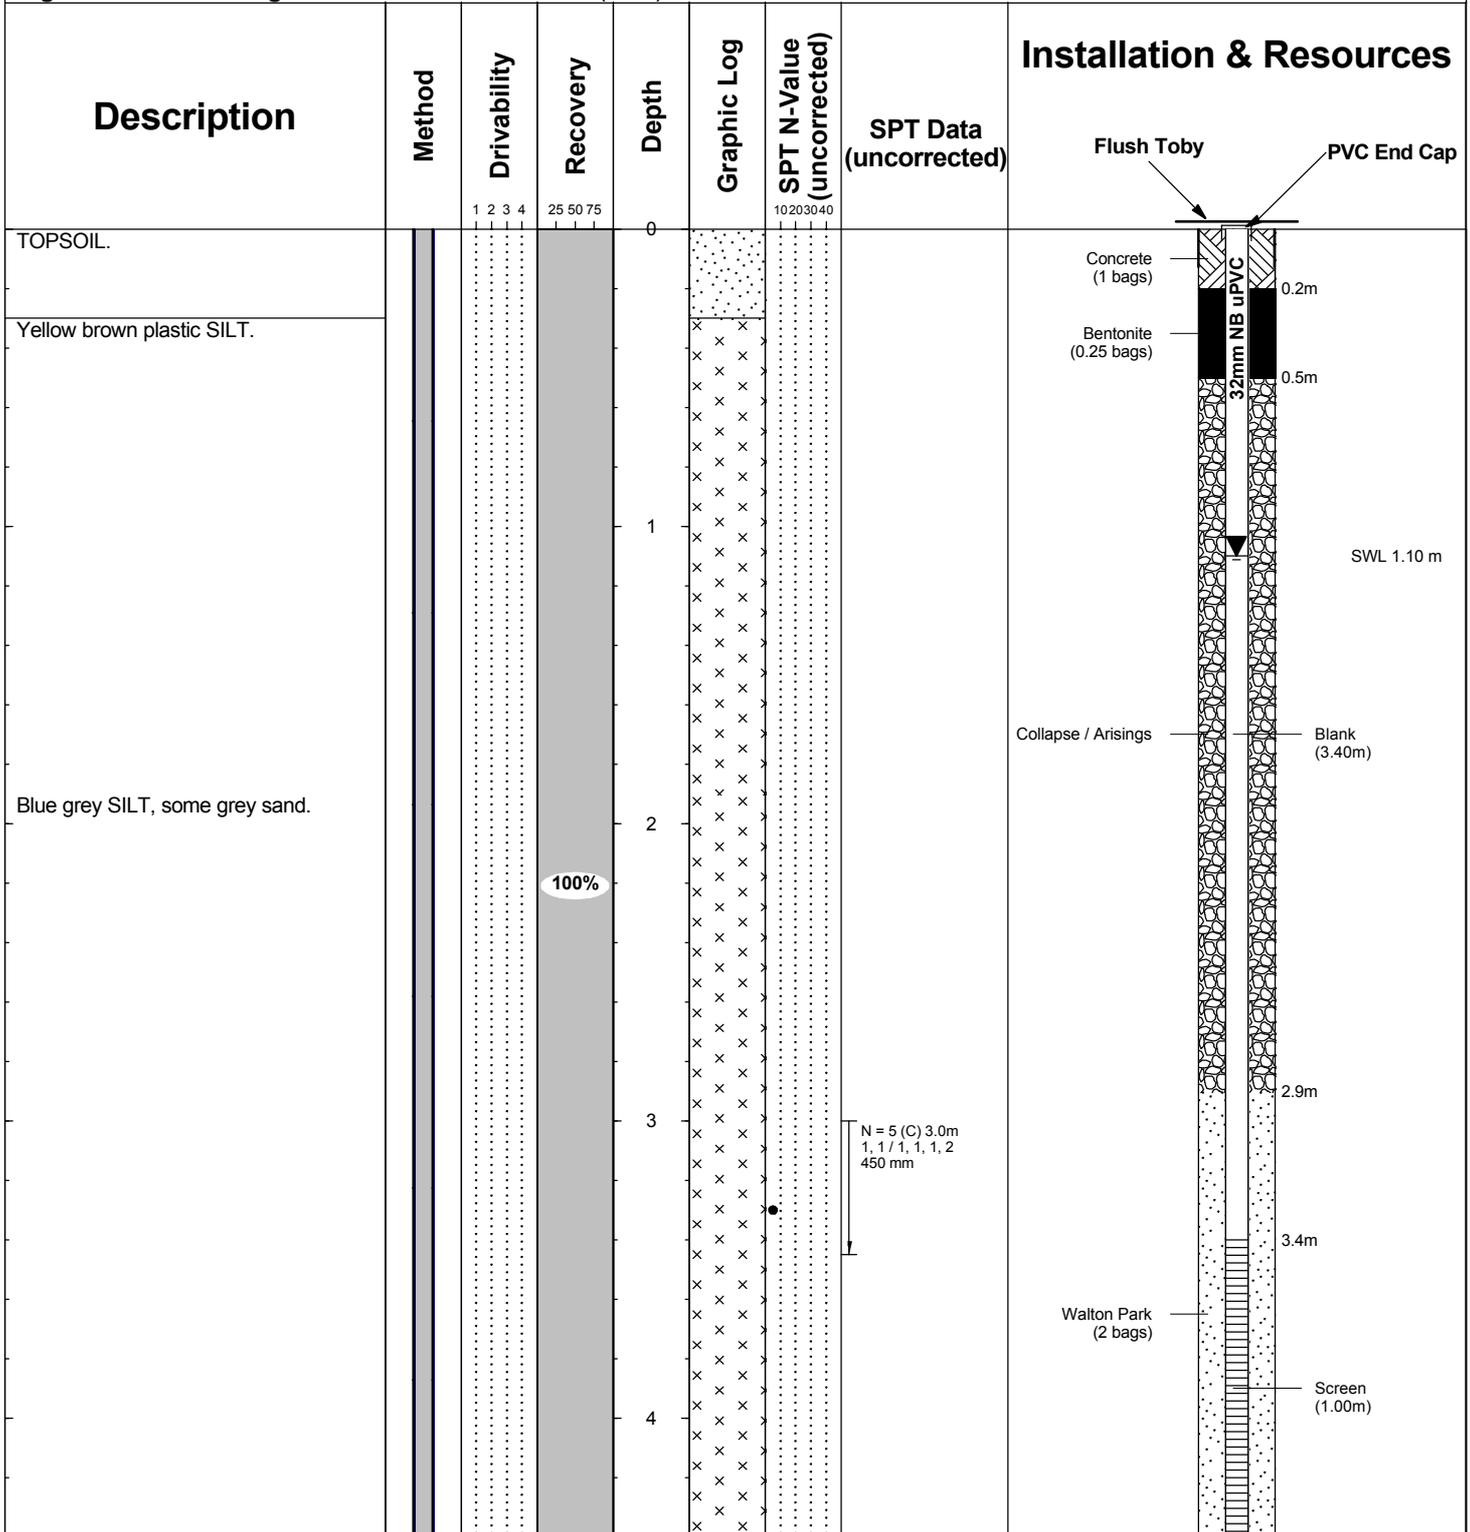
**Remarks:**  
 E.O.H 4.4m  
 Installation of Ground water monitoring well BH001.  
 SPT @ 3.0m  
 SPT: "Doughnut" trip SPT Hammer #001 used (energy ratio 52.0%)

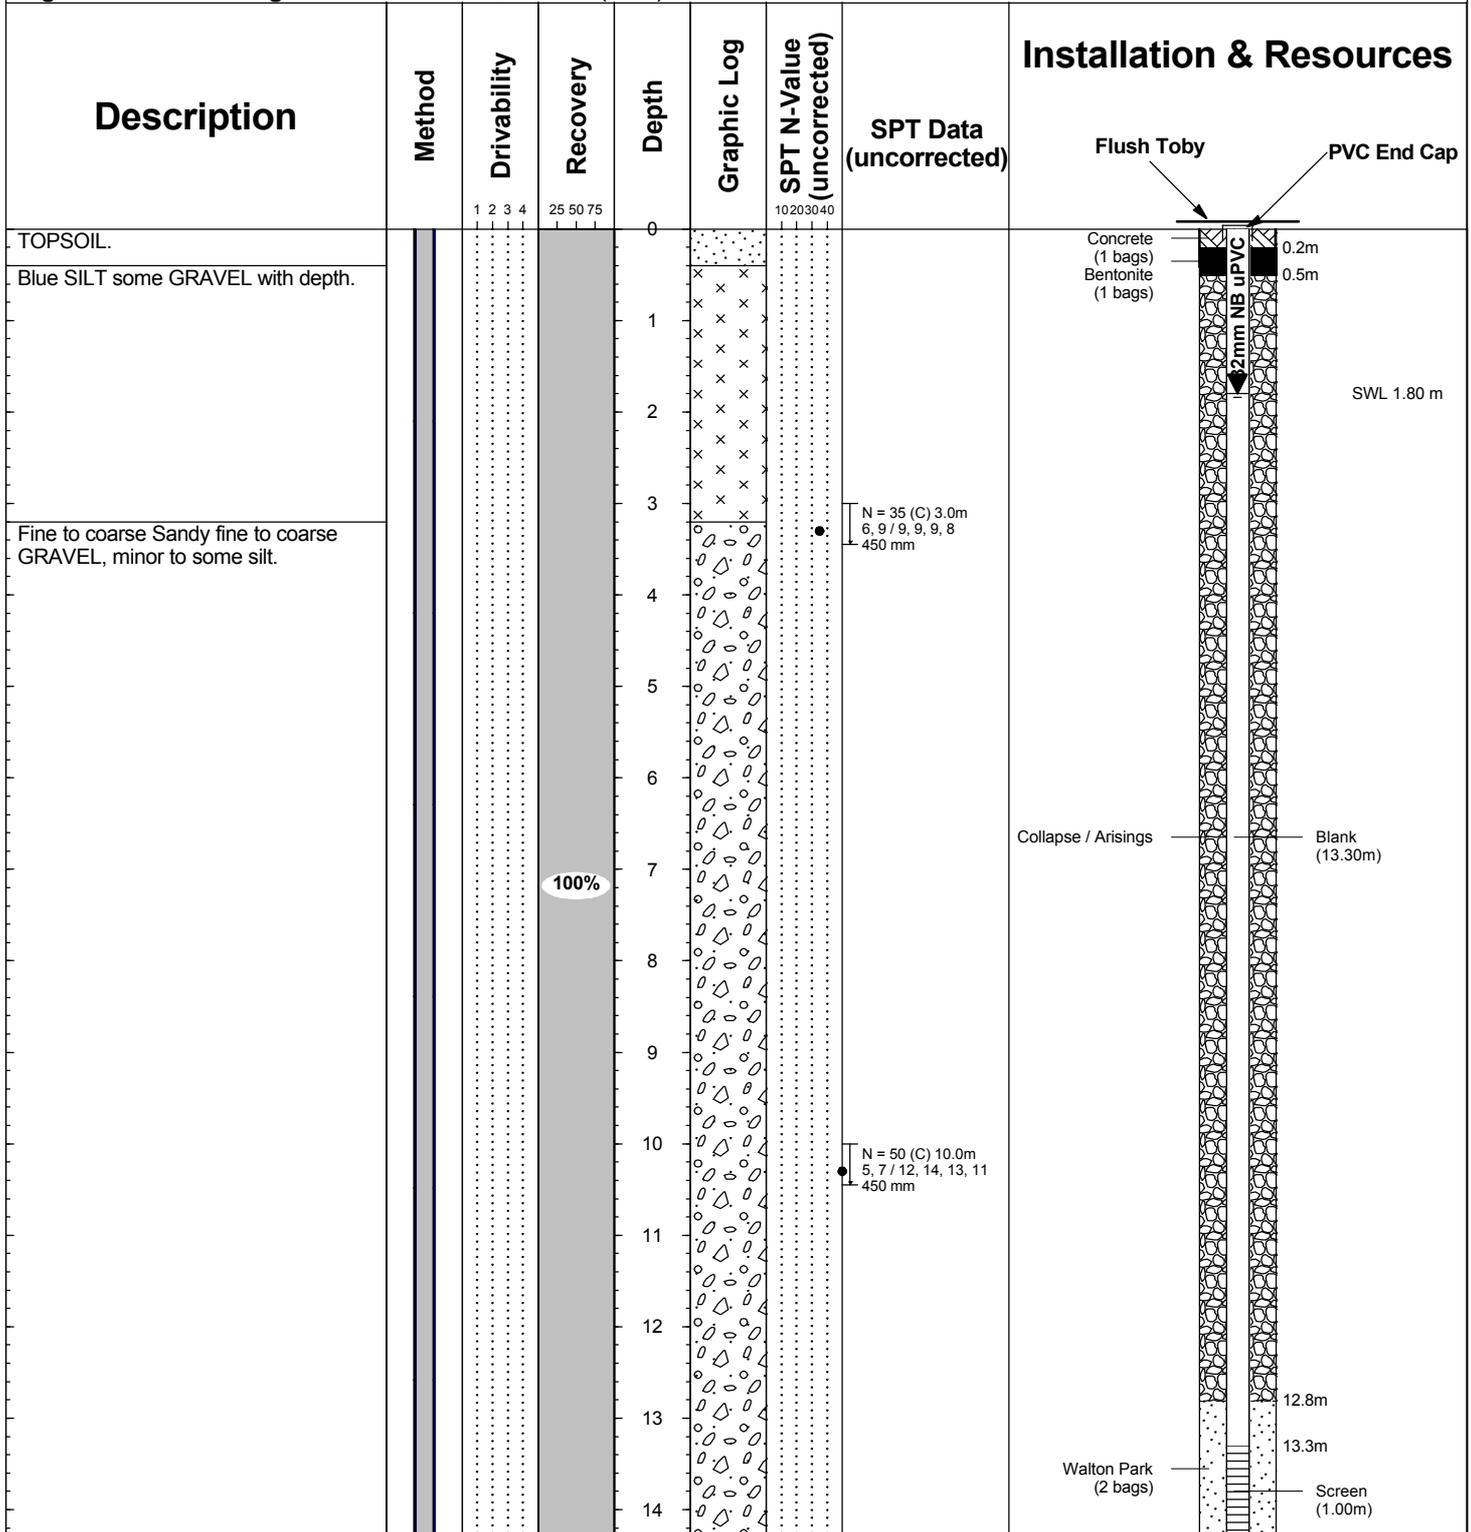
**Remarks:**  
 E.O.H 14.3m  
 Installation of Ground water monitoring well BH002.  
 SPT @ 3.0m and 10.0m  
 SPT: "Doughnut" trip SPT Hammer #001 used (energy ratio 52.0%)

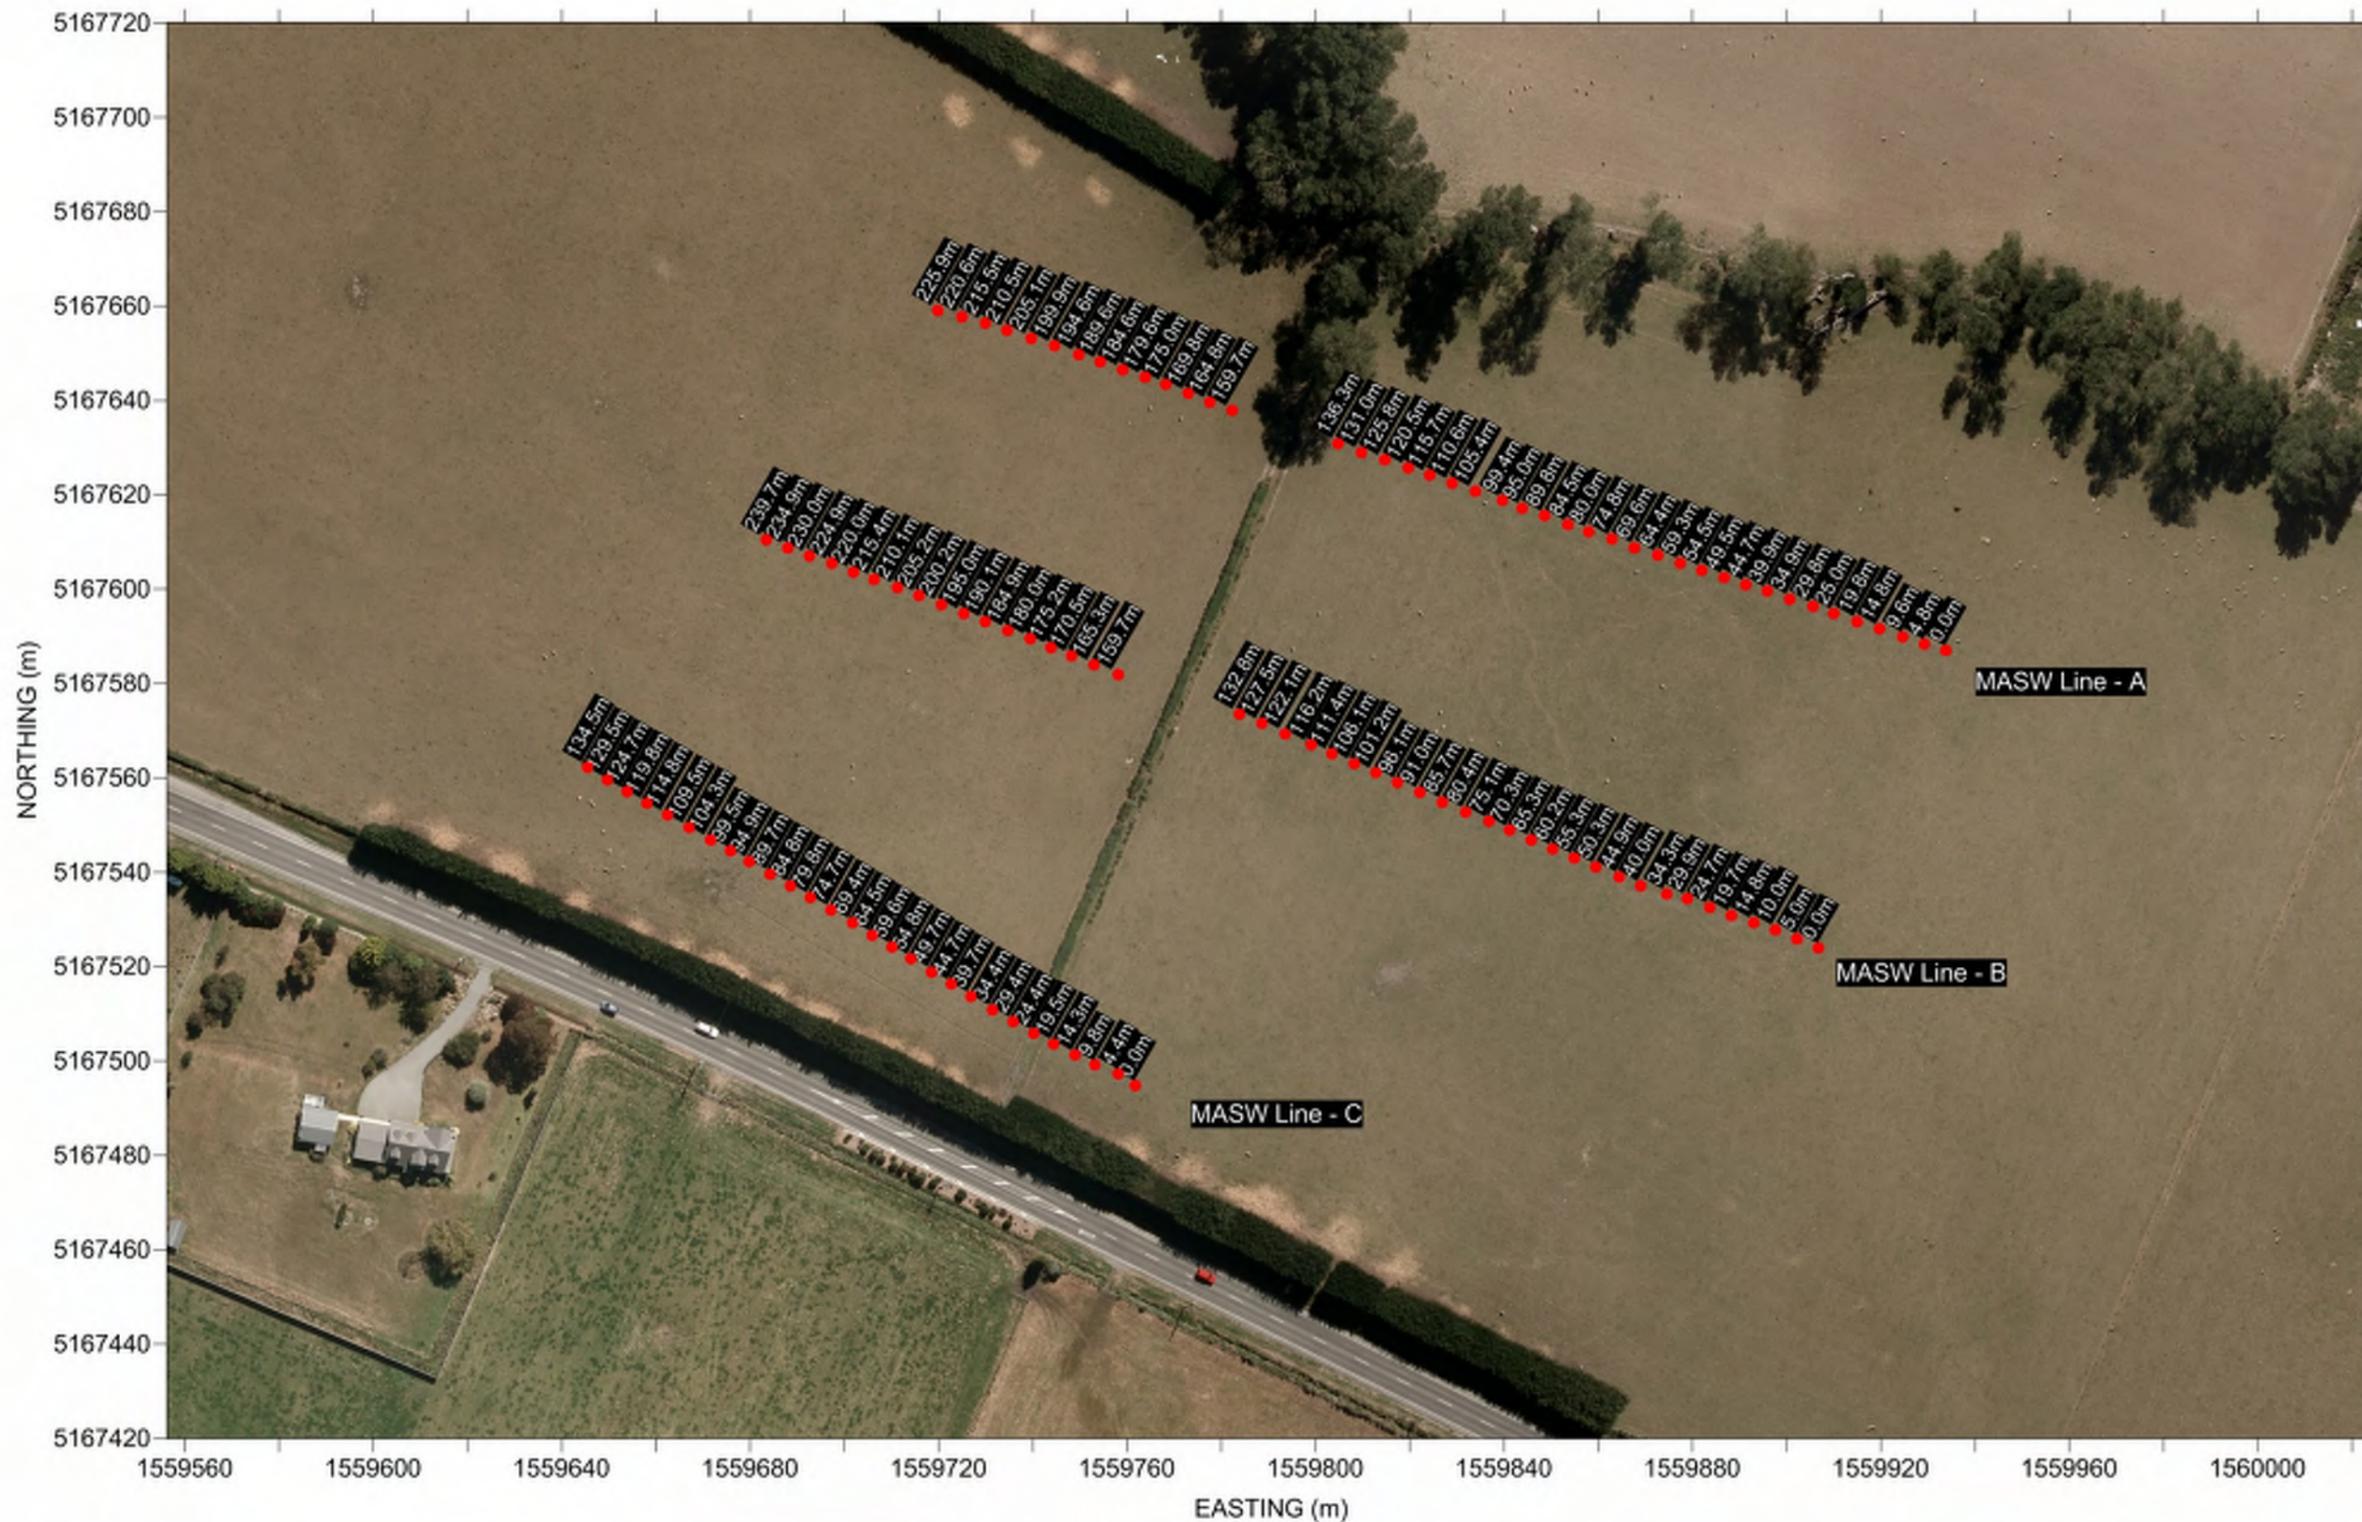
PROJECT- **MASW Investigation**

LOCATION- **Rosemerryn Farm Subdivision  
Lincoln, Canterbury**
