Geotechnical Assessment  
Report  
Rosemerryn Farm  
Stages 3 to 6  
Fulton Hogan Land  
Development Limited

Report ref:  
224464  
23 April 2012  
Revision 3

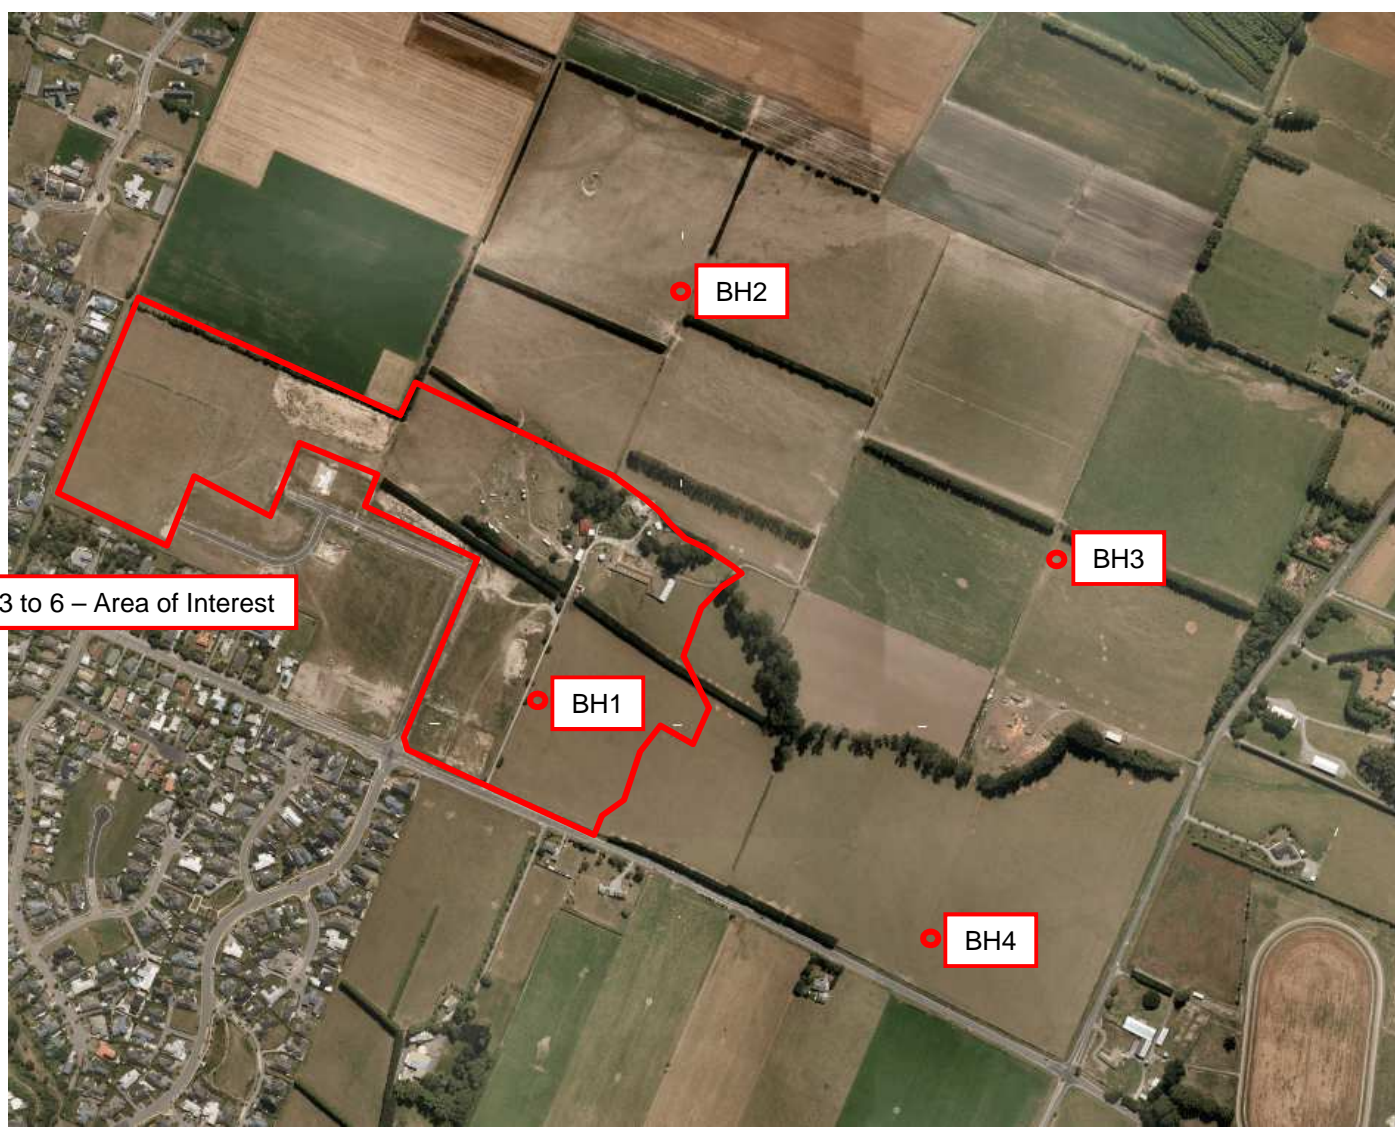
Figure 6	
ECan Borehole Location Plan	
Date	May 2012
Job Number	224464

Stage 3 to 6 – Area of Interest

A review of the Environment Canterbury GIS System (ECan, 2011) has been undertaken to identify borehole logs within the direct vicinity of Stages 3 to 6. The borehole logs ranged from 5.2m to 83m bgl in depth. The borehole locations are shown in Figure 6 and the logs are presented in Appendix F.
