# Rosemerryn Subdivision, Lincoln

Stages 19 to 24 Geotechnical  
Investigation Report

**Fulton Hogan Land  
Development Limited**

Reference: 224464

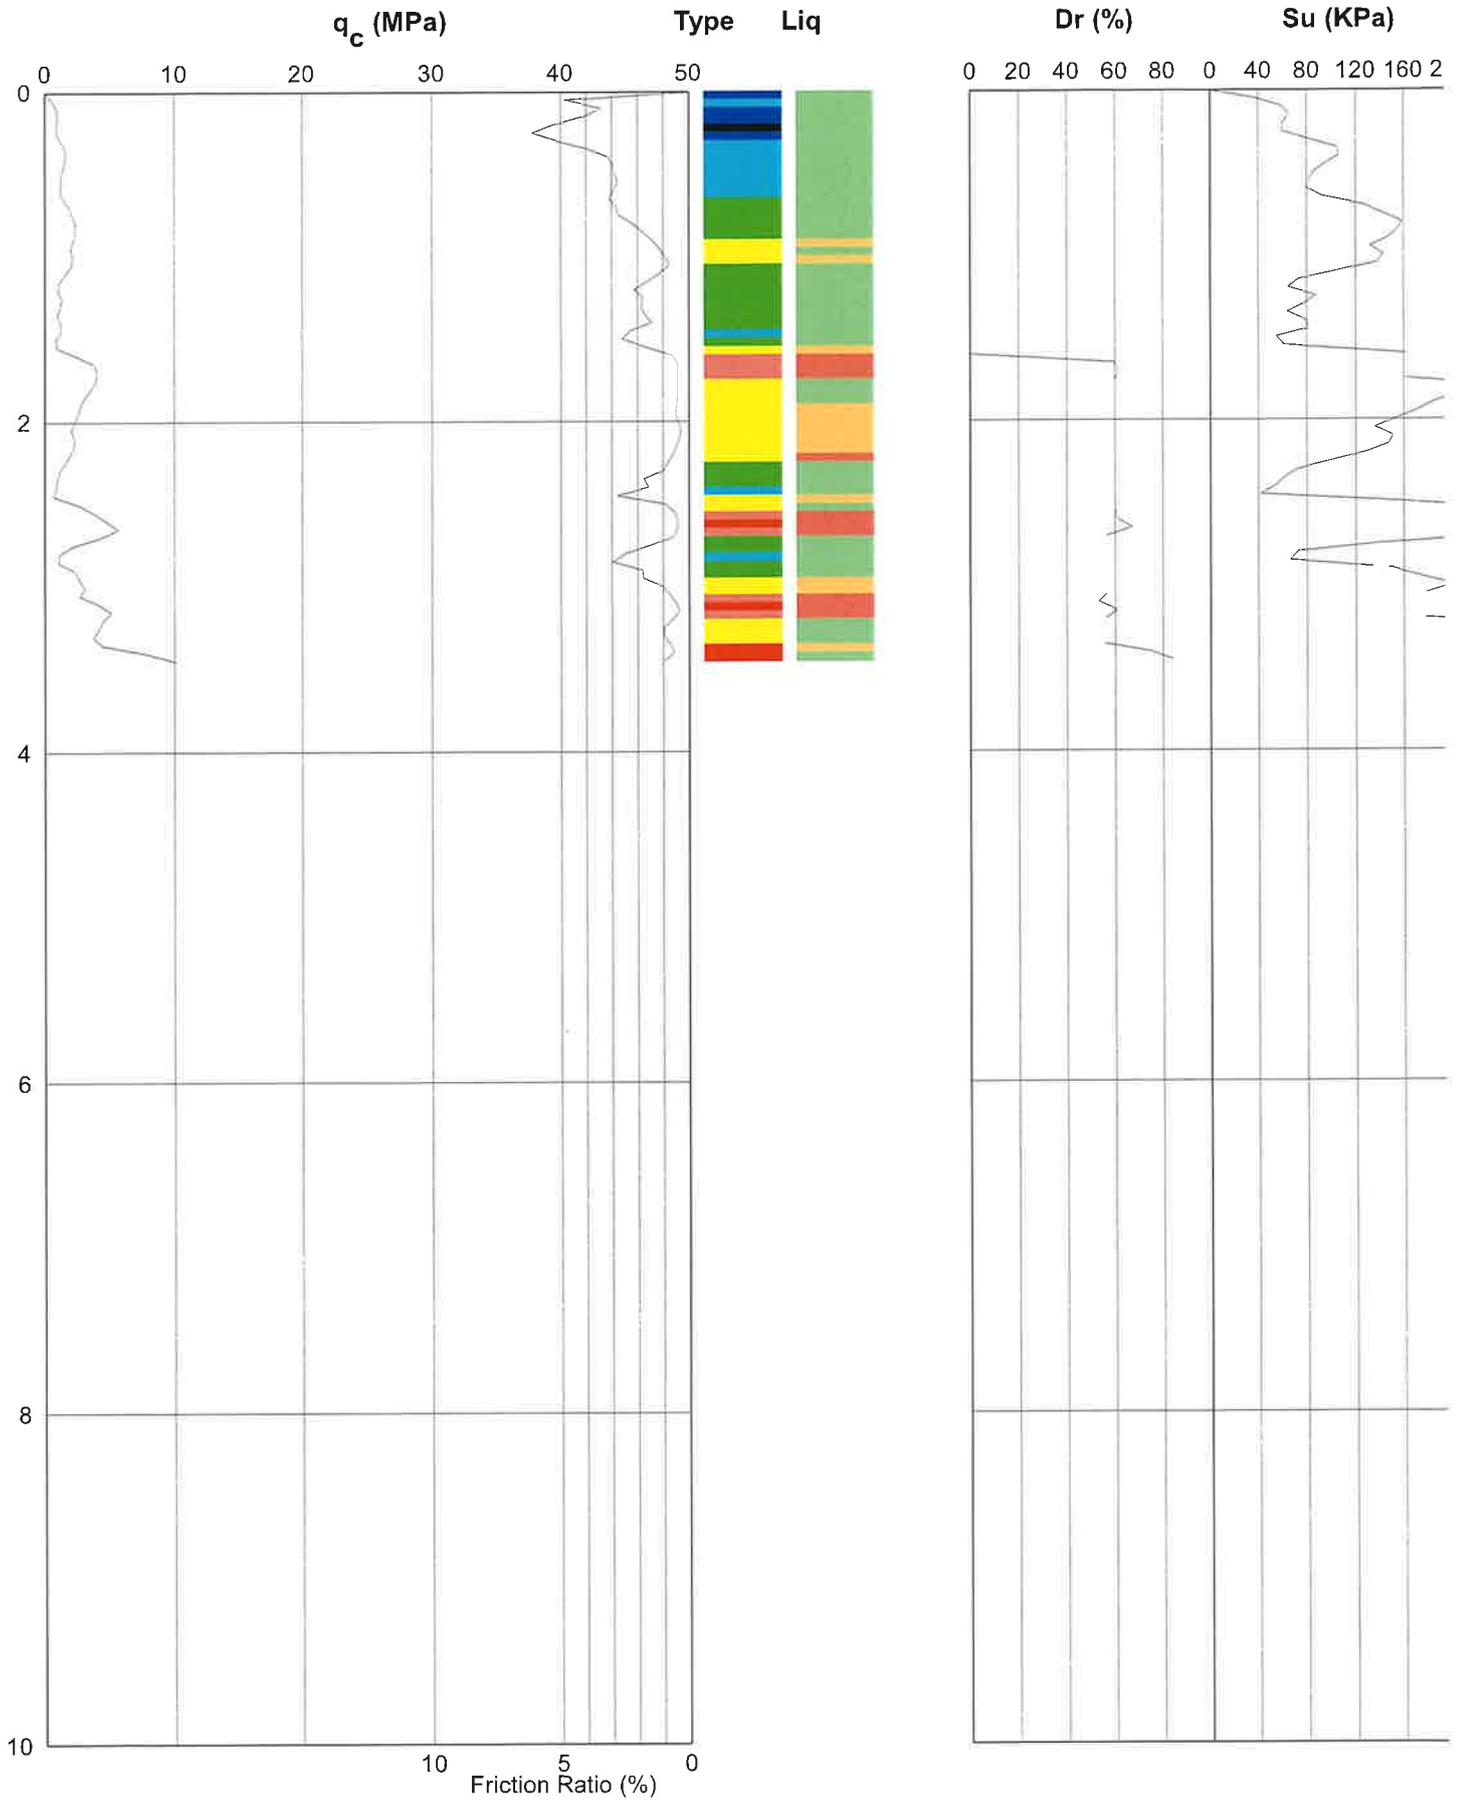
Job No: 9402  
 CPT No: CPTu019  
 Project: FH C/o Aurecon  
 Location: Rosemerryn, Edward St, Lincoln

Date: 27/08/11  
 Operator: J. Kendrick  
 Remark: Effective Refusal

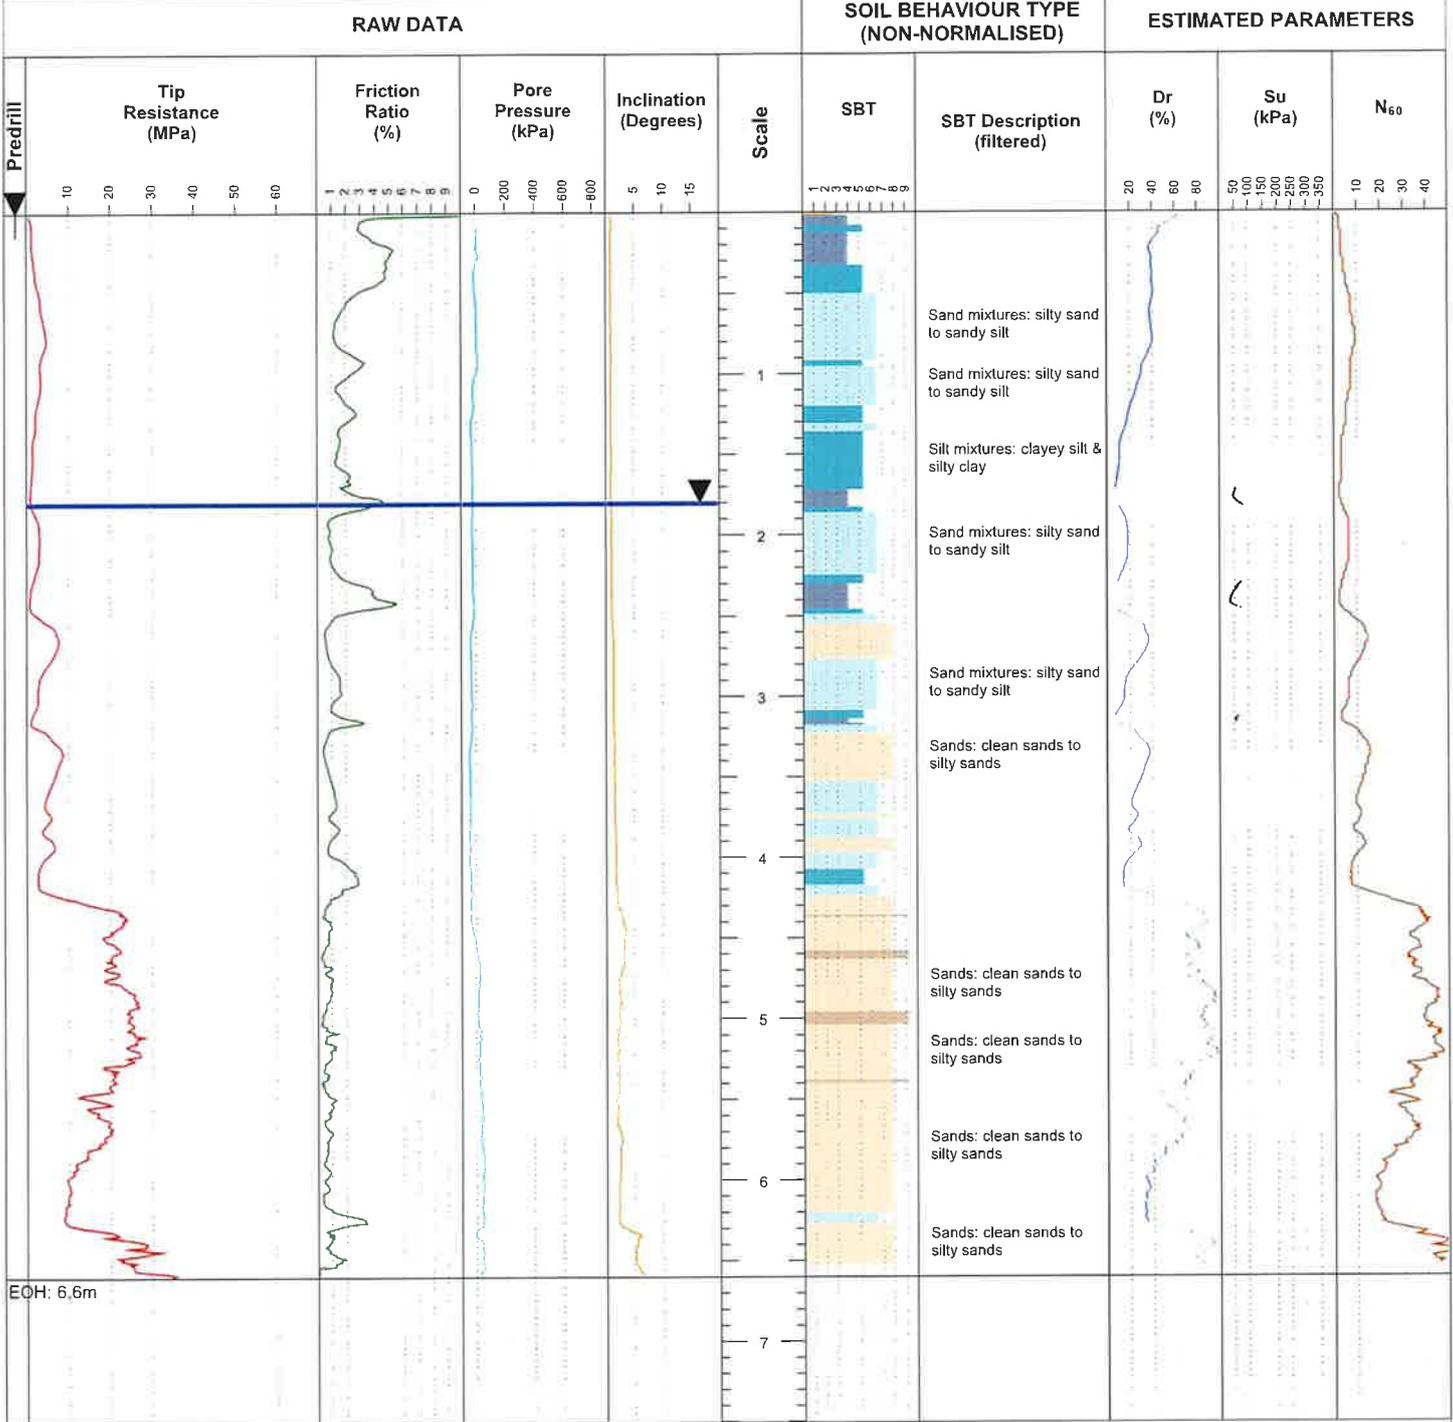
<b>Name:</b> Rosemerryn <b>Client:</b> Aurecon NZ Ltd <b>Location:</b> Ellesmere Road, Lincoln	Hole Depth (m): 6.60 Elevation (m): 0.00 Datum: Ground	North (m): 5167953.13 East (m): 1560131.90 Grid: NZTM
--	--	---

<b>Operator:</b> R. Wyllie <b>Rig:</b> Geomil Panther 100 <b>Cone Reference:</b> 160925 <b>Cone Area Ratio:</b> 0.75 <b>Cone Type:</b> I-CFYYP20-15 <b>Tip Resistance (MPa) Initial:</b> -1.4917 <b>Local Friction (MPa) Initial:</b> 0.0198 <b>Pore Pressure (kPa) Initial:</b> 0.0085	<b>Date:</b> 22/05/2018 <b>Predrill:</b> 0.00 <b>Water Level:</b> 1.80 <b>Collapse:</b> 4.00 <b>Final:</b> -1.3956 <b>Final:</b> 0.011 <b>Final:</b> 0.003	<b>Effective Refusal</b> <b>Tip:</b> <b>Gauge:</b> <b>Inclinometer:</b> ✓ <b>Other:</b> <b>Target Depth:</b>	<b>Soil Behaviour Type (SBT) - Robertson et al. 1986</b>

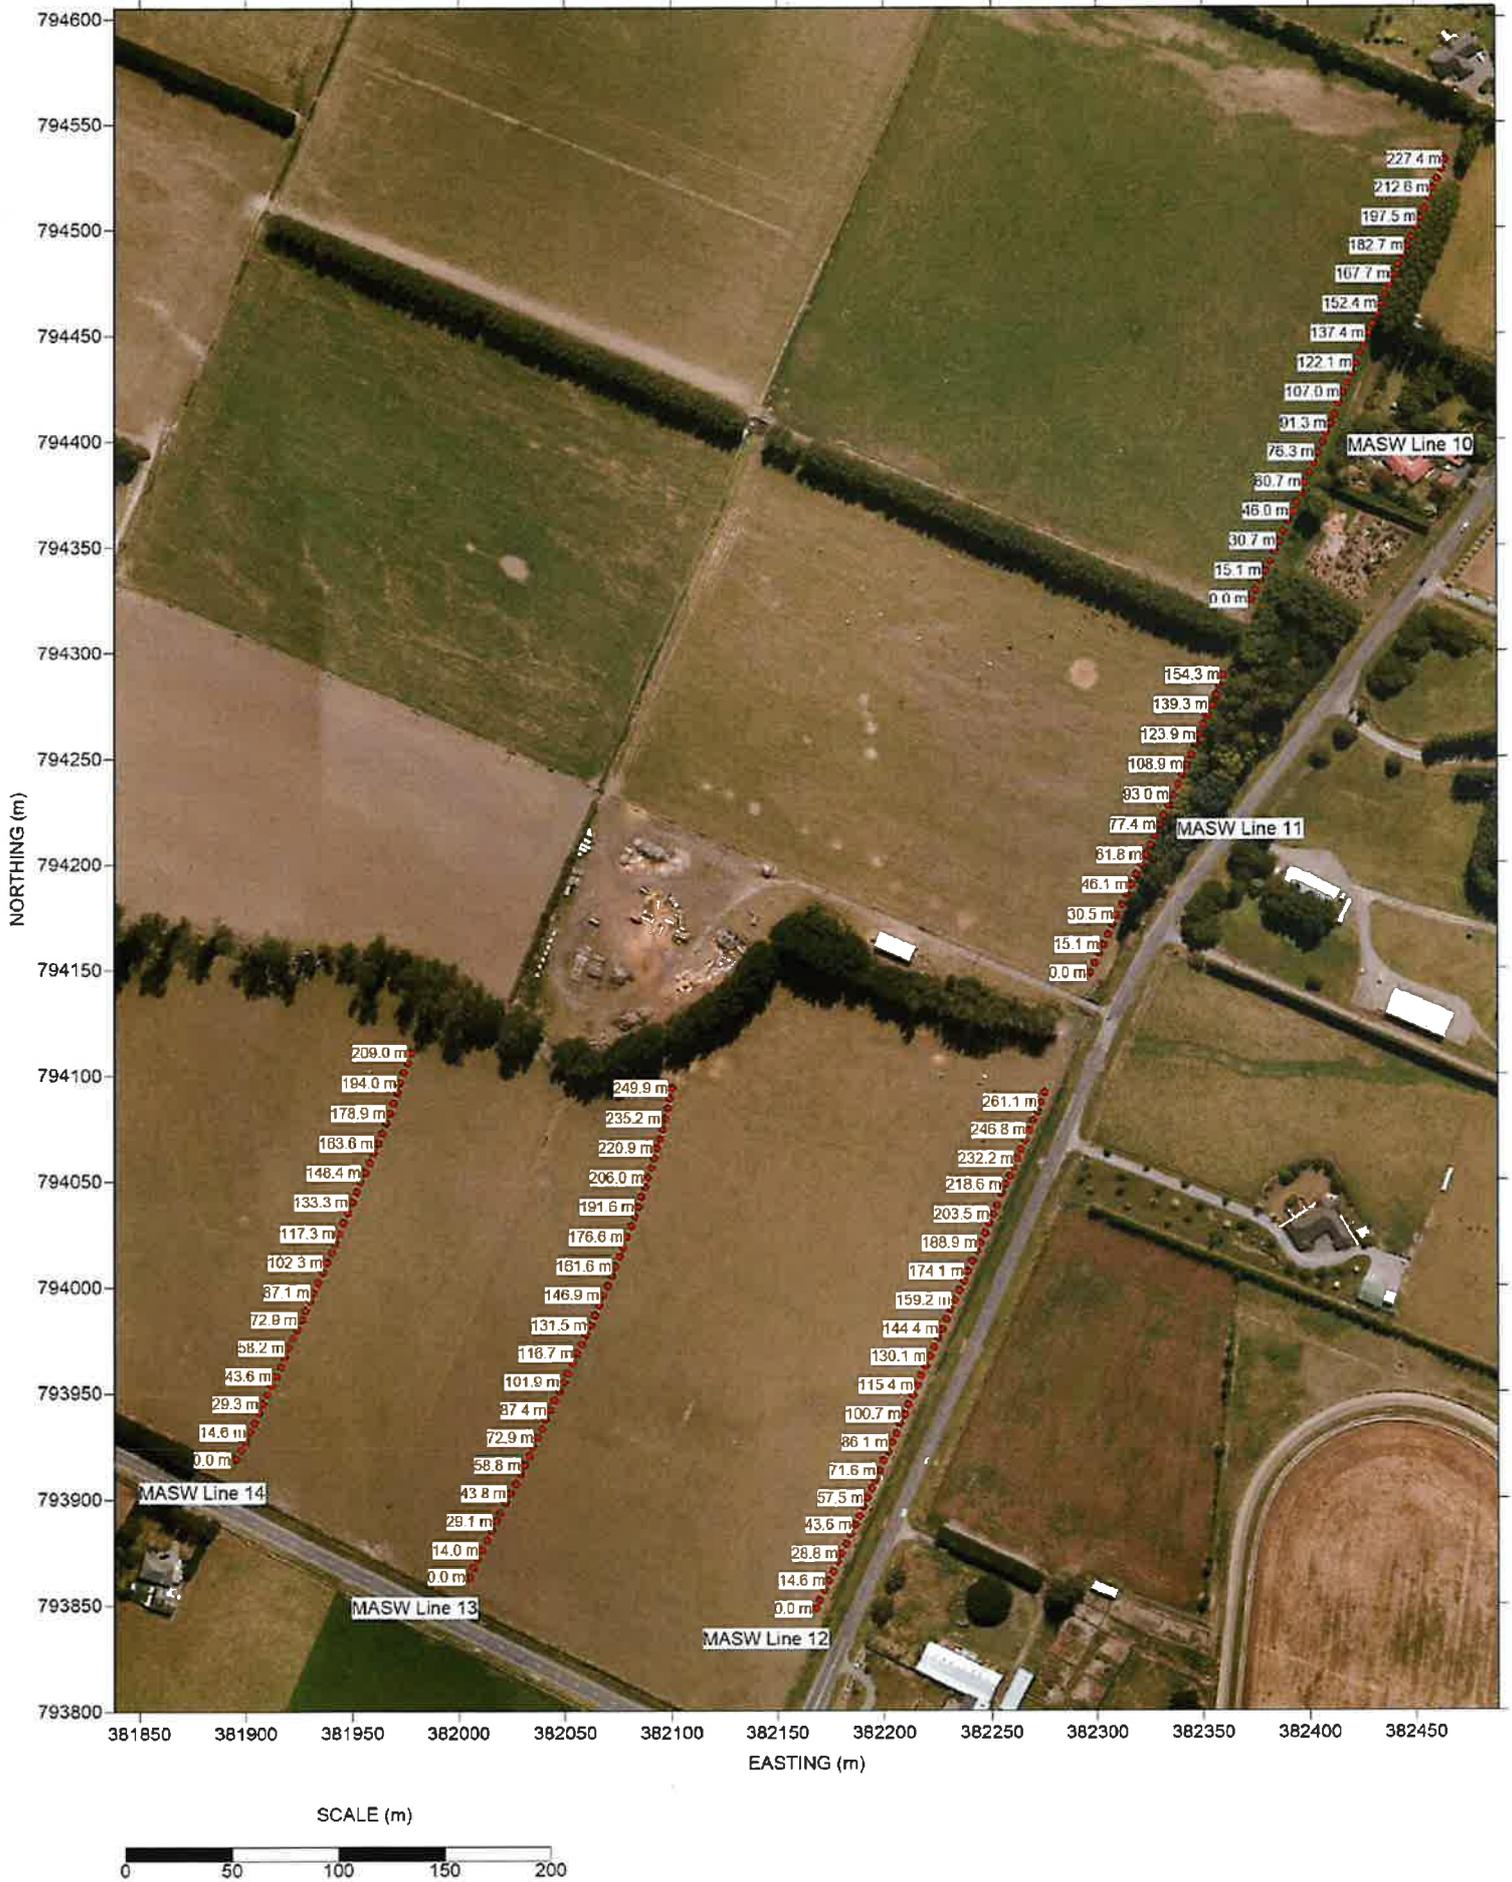
**Figure 1: MASW Survey Locations**

**Rosemerryn Stages 19 to 24, Lincoln**
